Changes in Cultural Heritage Activities: New Goals and Benefits for Economy and Society

IMPLEMENTATION OF MAINTENANCE SYSTEMS: INVESTIGATION ON EFFICACY OF MAINTENANCE PRACTICES IN BELGIUM

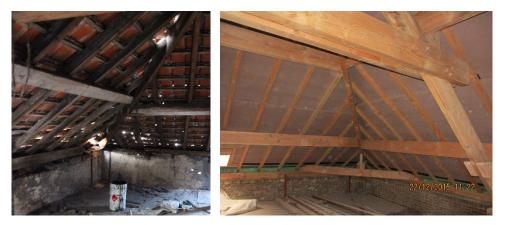
The lack of maintenance has created a number of problems regarding the preservation of the property. As part of the listing of the property, the Flemish Heritage Agency made a report of the building's condition in 2005. At that point, it was indicated the property was in a good state of preservation. In 2013, shortly after the new owners purchased the property, an inspection was done by Monumentenwacht. The report indicates that there a several leakages which have also jeopardized the stability of the roof structure. Furthermore, fungus attacks were detected in both structural and non-structural elements in timber throughout the building. Therefore, in 2014, funding was requested and obtained for the renewal of the roof structure and the roofing material. Very few elements of the 19th century roof structure were preserved, partly due to its poor state of preservation, but also since they structure was considered less valuable due to a poor assembly (probably the result of several interventions and repair) and poor timber quality of the 19th century softwood. The description of the works however indicates that the roof structure should be repaired and preserved, but it seems that during the course of the works the structure resulted being in such a poor state of preservation that renewal was preferred over repair. One can therefore state that the lack of maintenance works resulted in the loss of the 19th century roof structure of this building.

Fig. 1 – Left: roof structure before renewal, 2013 (picture by owner). Right: roof structure after renewal, 2015.

In 2015, funding was requested and obtained for the renewal of the windows and the wooden floors. Most of the existing wooden floors on the ground floor were deteriorated due to fungus attacks. Therefore, those wooden floors were completely renewed and good planks were recovered to restore the floors on the first floor. The windows were also deteriorated due to the lack of maintenance, resulting in the sills to be completely rotten. All windows were therefore replaced. Thus once can also state that the lack of maintenance also resulted in the loss of a large percentage of the wooden floors and of all the 19th century windows.

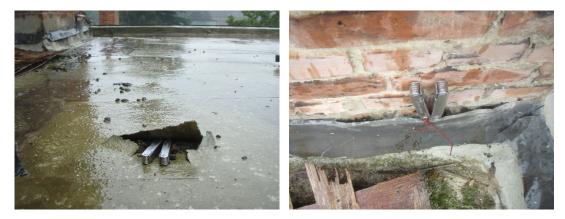
The good intent of the owner is undone by the inability to control the quality of executed interventions. The roof covering of the flat roof in roofing material, that had already been renewed in 1994, was completely renewed in 1999, based on the recommendations of Monumentenwacht, due to the sloppy placement of the initial covering and the poor execution of connections. After the intervention of 1999, problems were again detected regarding the sloppy placement of the roof covering, resulting in superficial cracks, mechanical damage, folding of the borders, loosening of connections and loosening of seams. In 2011, Monumentenwacht detected leakages, which were repaired in 2012.

Fig. 2 – Infiltrations in roof surface and connections, 2011. Pictures by MOWAv.

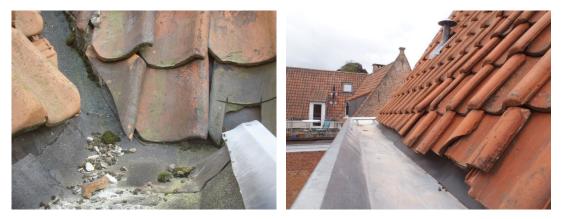
Regarding the gutters, the invoices of the 1985-1986 restoration project indicate that initially it was foreseen to line the timber gutters with zinc. On the 6th of December 1985, the contractor proposed a reduced price for realizing the lining of the gutter bottoms in asphalt, while the elevations are lined with zinc, that is nailed to the gutter's timber frame. The initial inspection report of Monumentenwacht dates back to 2001, so 15 years after the execution. The report indicates that the applied materials are less durable and refers to a number of problems with the execution. Firstly, the lining of the gutter bottoms in asphalt tends to fold up, a

problem that already caused leakages of which some had been repaired in the past. The report of 2001 mentions previous repairs of leakages. Secondly, the lining of the elevations in zinc demonstrated problems of loosening of the soldered seams, which again caused infiltrations. Furthermore, there is a technical design issue that aggravates the situation: some of the downpipes were eliminated during the restoration works of 1985-1986, which resulted in a reduced slope of the gutter towards different exits. Water was therefore less efficiently drained and rainwater would stand in the gutter. The combined issues led to decay of the gutter's timber structure, which in 2005 is mentioned to have caused a subsiding of the gutter structure, again resulting in more standing water in the gutters. Some of the problems were temporary repaired with often non-durable techniques and materials. For example, the leakages of the gutter bottoms in asphalt were repaired by gluing lead flashings onto the asphalt, but the glue would loosen, leading again to leakages. Those leakages were then again repaired with more gluing. This temporary repairs continue until the replacement of all the gutters with new zinc linings in 2014.

Fig. 3 – Left: gutters in asphalt, 2011. Right: new gutters with zinc linings, 2015. Pictures by MOWAv.

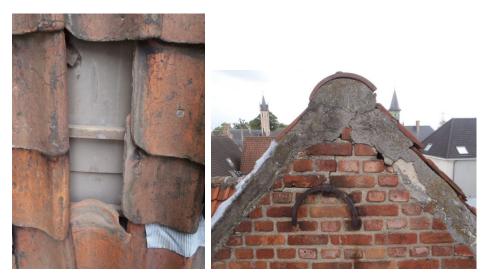
Regarding the roof covering in ceramic tiles, there were four design issues regarding its initial placement in 1986: (1) a sloppy placement of the ceramic tiles, (2) the use of different tile sizes, (3) the lack of a double tiling batten to support the lower row of tiles, (4) the durability of the applied materials. The first two issues were only mentioned for the first time by Monumentenwacht in 2011, when it was clear that the sloppy placement lead to a bad connection between the tiles and the shifting of the tiles. Some of the shifted tiles were repositioned using building foam or they were repaired with adhesive tape. The lack of the double tiling batten led to the shifting of the lower row of tiles and the uncovering of the ends of the pan laths and the roof sheathing, which accelerated their deterioration. Strangely this design issues was not resolved during the placement of new gutters in 2014. Finally, the durability of the applied materials, is related to the reuse of existing tiles for the restoration of 1986. It was common practice at that time to use recycled old tiles from other buildings for restoration projects, to give the roof coverings an authentic character. Already in 2014, only 28 years after the placement of the tiles, the reports of Monumentenwacht indicate the first signs of deterioration of the roof tiles. The initial superficial deteriorations increase the tiles' porosity, which leads to a higher rate of water absorption and increases the chance of mechanical damage due to frost. Another issue regarding durability of applied materials is the use of cement based mortars for connections of ridges and raised gables, which leads to deterioration of the hard mortars and local infiltrations. The roof coverings are planned to be replaced with government funding in 2017, only 30 years after their initial placement.

Fig. 4 – Left: uncovering of roof sheathing and pan laths due to shifting of tiles, 2015. Right: deterioration at connection raised gable due to incompatible cement based mortar, 2015. Pictures by MOWAv.

This case demonstrated how design choices lead to a reduced life time for the elements of the rainwater disposal system. The detected issues were furthermore repaired temporarily with less durable methods and materials, awaiting a renewal of the entire component with more durable materials. The main question is if after the renewal the owners will also apply more durable repair methods. Based on the interviews with the owner of case 5, it was clear that the methods of repair are not decided by the owner, but by the contractor. The owner directly takes the report of Monumentenwacht to the contractor who solves the issues.
