Changes in Cultural Heritage Activities: New Goals and Benefits for Economy and Society

CHANGES is a European Project supported by the JPI Heritage Plus program.

WP5**IMPLEMENTATION OF MAINTENANCE SYSTEMS:
INVESTIGATION ON EFFICACY OF MAINTENANCE PRACTICES IN ITALY****Responsible**

CASE STUDY N. 7: MONITORING - SAFETY FOR STRUCTURAL HAZARD.

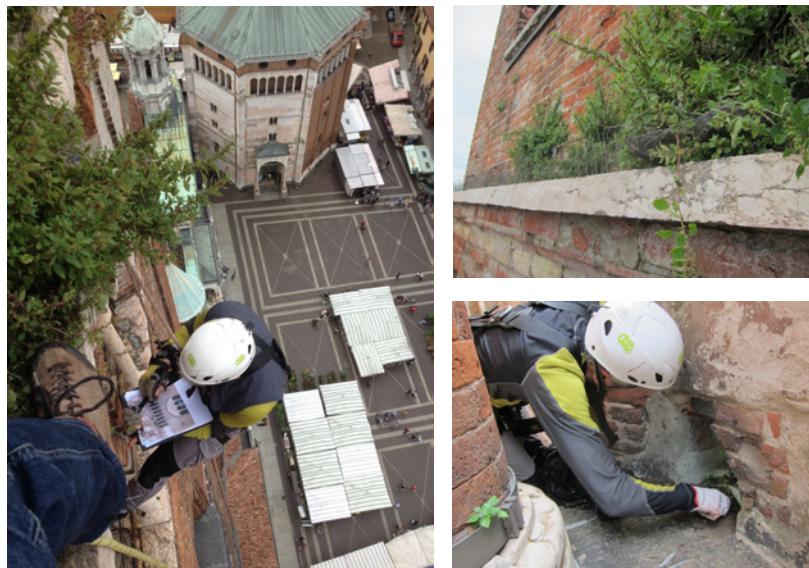
Torrazzo in Cremona: inspection activities operated with access and positioning techniques by ropes; the inspection proved that the growth of vegetation was mainly caused by the lack of maintenance of gargoyles.

The inspection proved that the growth of vegetation was mainly caused by the lack of maintenance of gargoyles. An additional problem was observed: in the 80's the *Ghirlandina* was strengthened with a reinforced concrete structure, that currently presents significant degradation signals that require further investigations.

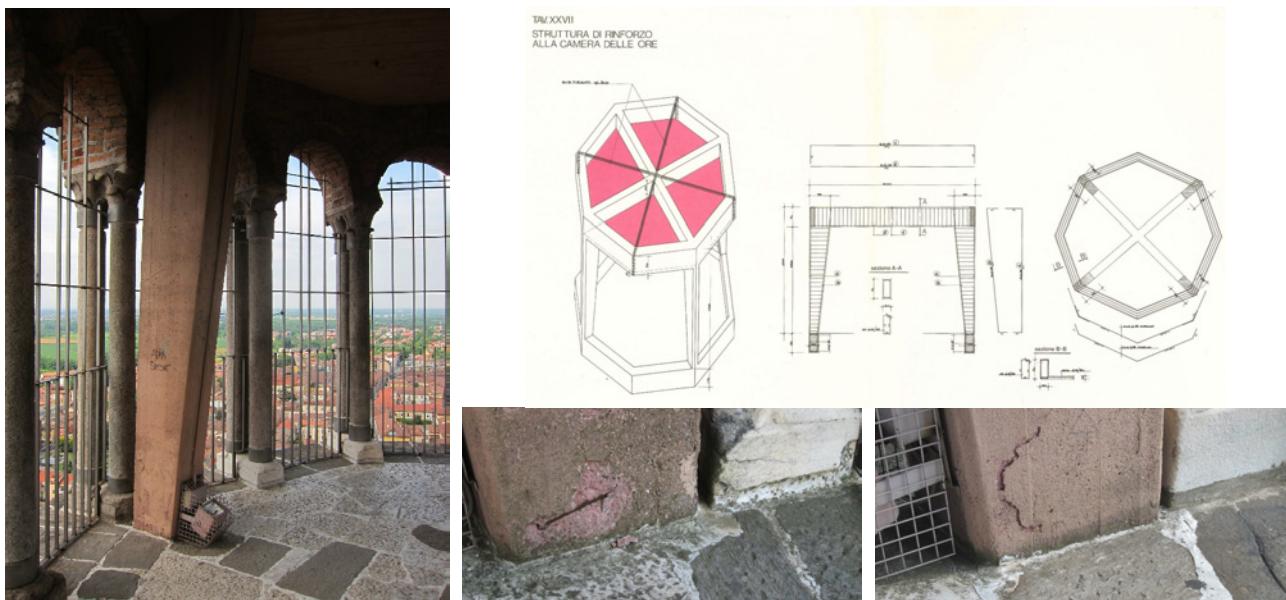
Torrazzo in Cremona: in the 80's the *Ghirlandina* was strengthened with a reinforced concrete structure, that currently presents significant degradation signals that require further investigations.

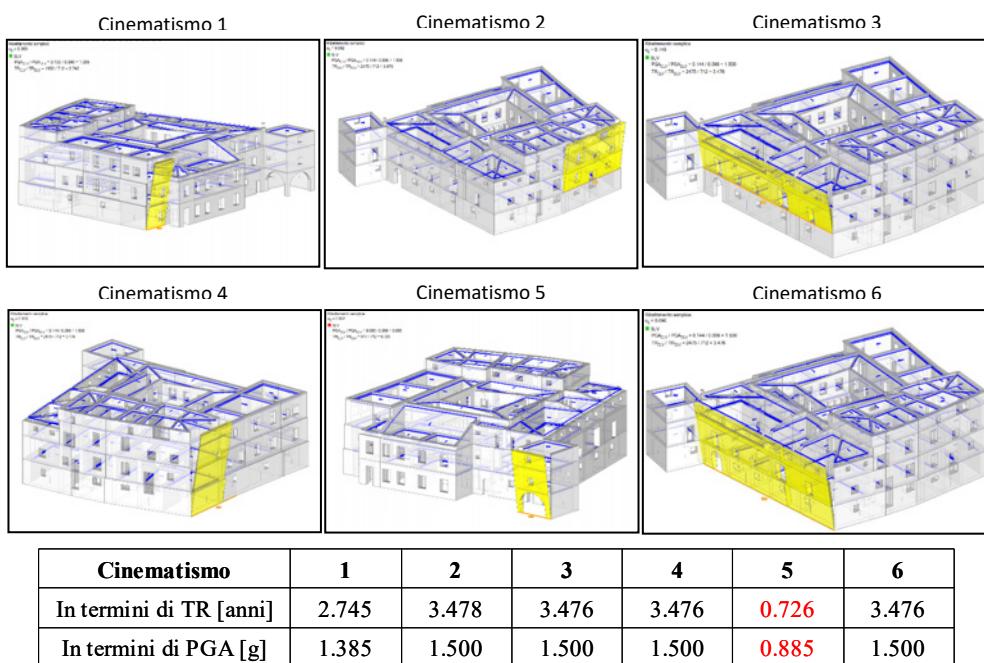
Evaluation of the seismic vulnerability at the Level LV2 in the Besta Palace in Teglio: analysis of the local collapse mechanisms.

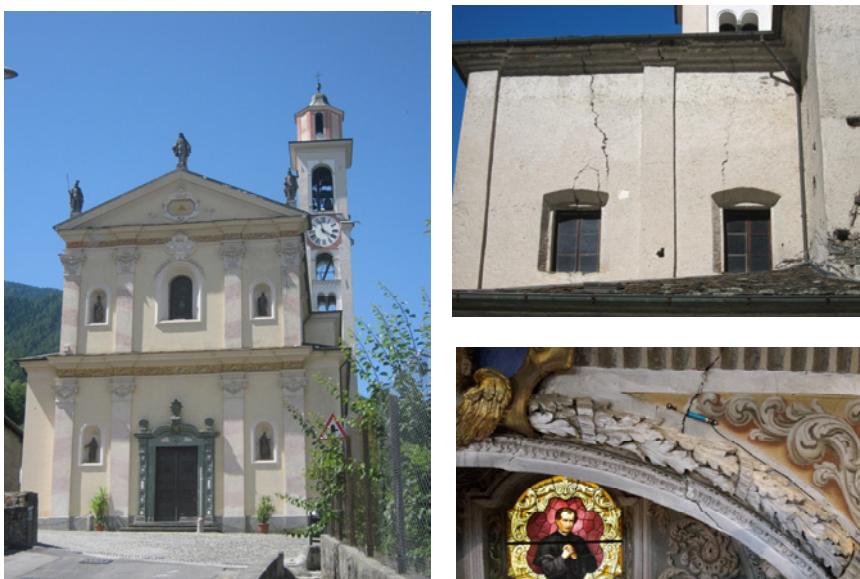
The visual inspection of the structure and the survey of the cracking pattern were carried out with methods similar to the other case studies previously described. In addition to the representation of the cracks (plans and elevations), a structural inspection report was drawn up where all the individual cracks were coded and identified with photograph, description of the width, gravity, urgency and correspondence with other cracks. The walls of the church are affected by a complex crack pattern, as it is possible to see in the image below.

S. Maria Church in Lovero displays a wide crack pattern. It was installed a structural monitoring system.

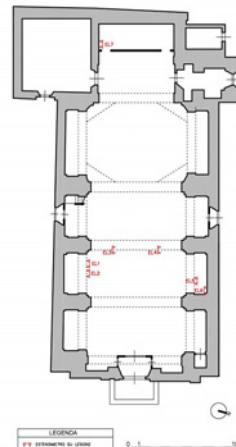
Temperature / Base	Trend (2015-2017) [mm/ year]
ΔT	(balanced)
EL1	0,027,
EL2	0,005
EL3	0,064
EL4	0,072
EL5	0,0022
EL6	0,048
EL7	0,028

Lay-out of the monitoring and qualitative evaluation of the trend.

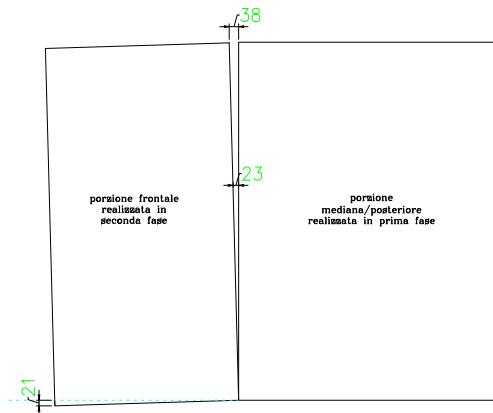
The amount of the differential settlements between the buttresses 1 and 2 (caused by the presence in the subsoil of a subsident material portion of increasing thickness towards the main façade) justify the formation of the cracks on the side walls of the church as they allow to hypothesize a rigid rotation of the first bay of the church according to the kinematic sketched in the image below. The congruence of the scheme with respect to the actual situation is confirmed by the fact that the calculated opening of the joint between the two structural portions is compatible with the cumulative width of the detected cracks.

Sketch of the displacement caused by the failure of the front portion of the Church.

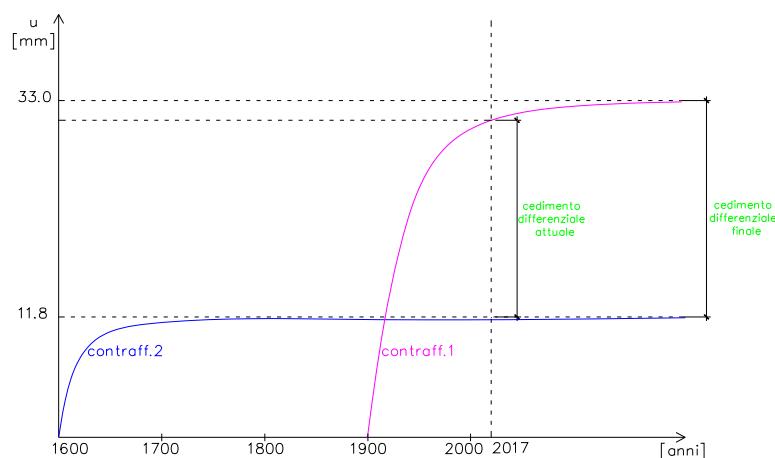
increase in subsidence of the façade, which should be limited to a few mm. This forecast is consistent with the data provided by the monitoring system which has effectively highlighted the fact that the cracking phenomena are still active, but with a low annual trend (maximum values lower than 0.08 mm / year). On the basis of these considerations, structural problems that are significant for the building are not expected in the short or long term. The building tends over time to find a state of equilibrium with foundation subsidence. However it cannot be excluded that such failures cause further small detachments of portions of plaster and decorative elements, as occurred in the recent past.

Graph of the deformation over time.

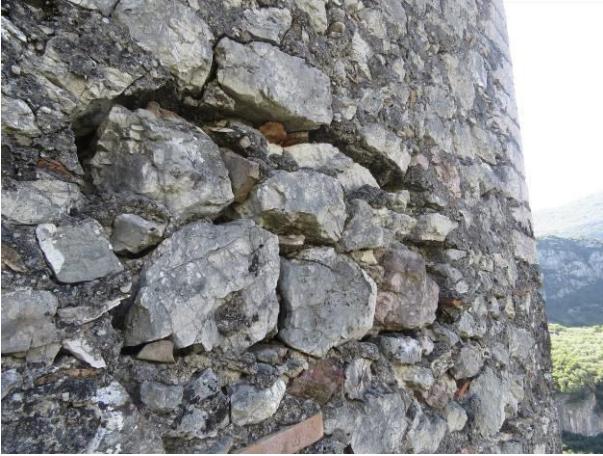
DISGREGAZIONE GIUNTI DI MURATURA				DIFFUSIONE	0-25%

DESCRIZIONE				
Il prospetto presenta disaggregazione profonda delle malte di allettamento fino a risultare assenti per tutta la profondità dei primi conci che infatti si sono adagiati su se stessi.				ISTRUZIONI				
Le aree degradate rappresentano risultano molto localizzate fatto che può far pensare a non meglio precisati fenomeni circoscritti, che andranno indagati in occasione dell'auspicato intervento di messa in sicurezza.				DOCUMENTAZIONE	IMG_0182			
GRAVITÀ				URGENZA				
Il fenomeno che interessa la muratura sebbene localizzato risulta puntualmente grave.				Le pietre risultano sostanzialmente non legate con possibilità di imminente caduta delle medesime lungo il versante e la conseguente instabilizzazione di ulteriori porzioni di muratura, come già visibile.				
3	CONSERVATIVA	1	2	3	CONSERVATIVA	1	2	3
	FRUIBILITÀ	1	2	3	FRUIBILITÀ	1	2	3

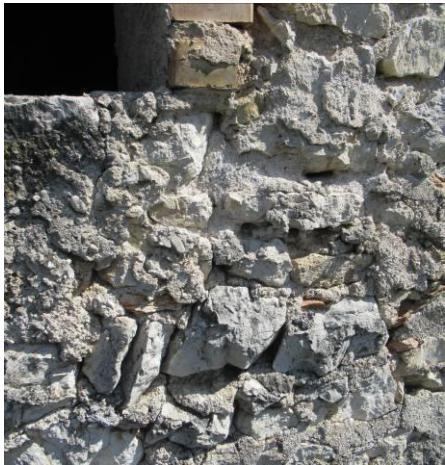
DISGREGAZIONE GIUNTI DI MURATURA			DIFFUSIONE

DESCRIZIONE	La muratura risulta disgregata in corrispondenza del parapetto della finestra superiore e dei piedritti della finestra inferiore									
			ISTRUZIONI	Le aree degradate sono molto localizzate e risultano evidentemente attribuibili a fenomeni circoscritti correlati alla presenza delle aperture.									
			DOCUMENTAZIONE	IMG_4504									
GRAVITÀ			URGENZA										
Il fenomeno che interessa la muratura risulta localizzato.			Il fenomeno può progredire causando la sconnessione delle pietre.										
2	CONSERVATIVA	1	2	3	2	CONSERVATIVA	1	2	3				
	FRUIBILITÀ	1	2	3		FRUIBILITÀ	1	2	3				
	ECONOMICA	1	2	3		ECONOMICA	1	2	3

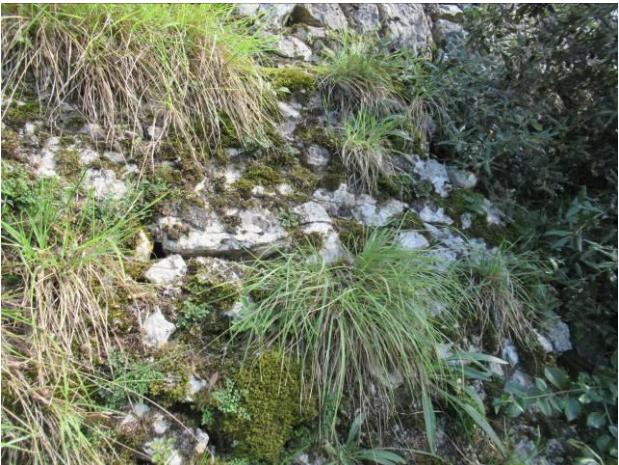
COLONIZZAZIONE BIOLOGICA			DIFFUSIONE

DESCRIZIONE	Il colore scuro visibile nella parte bassa della muratura corrisponde ad una forte presenza di licheni. La muratura della scarpa è ricoperta di muschio e presenta sviluppo di vegetazione superiore nei giunti, ma risulta tuttavia in buone condizioni di conservazione con pochi distacchi localizzati.									
			ISTRUZIONI	La presenza di licheni non costituisce un problema di conservazione e può essere correlata alla possibile presenza di una malta differente forse da mettere in relazione a restauri moderni. La presenza della muratura al piede della muratura favorisce l'accrescimento di piante superiori.									
			DOCUMENTAZIONE	IMG_4520									
GRAVITÀ			URGENZA										
La presenza di muschi non appare rilevante. La presenza di piante superiori può favorire un'ulteriore colonizzazione.			le piante superiori devono essere rimosse perché il loro progredire può causare problemi di scalzamento dei blocchi.

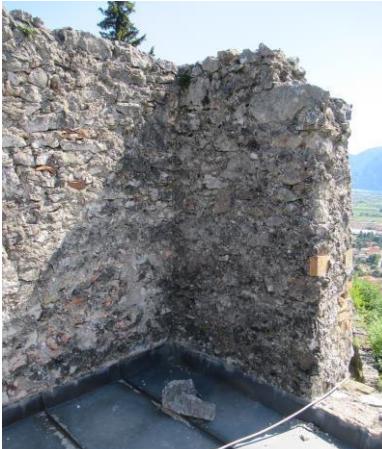
DISGREGAZIONE CORONAMENTO				DIFFUSIONE

DESCRIZIONE							
				La muratura del rialzo dello spigolo Sud-Ovest ha evidenziato la caduta di un blocco del coronamento che attualmente risulta depositato sulla copertura interna.							
				ISTRUZIONI							
				Il coronamento deve essere revisionato mediante creazione di una superficie di sacrificio che consenta di allontanare le acque meteoriche con sigillatura idonea dei giunti							
				DOCUMENTAZIONE		IMG_4498					
GRAVITÀ				URGENZA							
Il fenomeno che interessa la muratura sebbene localizzato risulta puntualmente grave.				Le pietre del coronamento risultano sostanzialmente non legate con possibilità di imminente caduta delle medesime.							
3	CONSERVATIVA	1	2	3	3	CONSERVATIVA	1	2	3		
	FRUIBILITÀ	1	2	3		FRUIBILITÀ	1	2	3		
	ECONOMICA	1	2	3		ECONOMICA	1	2	3

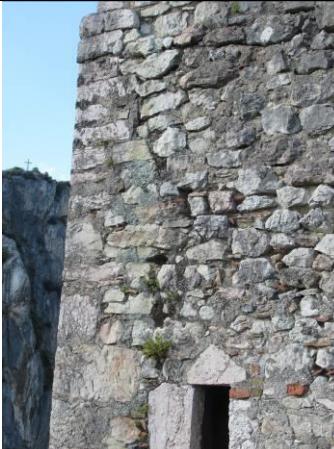
FESSURAZIONE / DISGREGAZIONE				DIFFUSIONE

DESCRIZIONE							
				Alcuni disaggregazioni sono presenti in corrispondenza della fessura sigillata dello spigolo Nord e ne attestano la non accurata sigillatura							
				ISTRUZIONI							
				Tali disaggregazioni non paiono attribuibili a movimenti attivi, ma possono costituire un problema in quanto possono costituire una via preferenziale per l'infiltrazione di acque meteoriche all'interno del corpo murario							
				DOCUMENTAZIONE		IMG_4547					
GRAVITÀ				URGENZA							
Il fenomeno che interessa la muratura seppur diffuso non appare grave per tipologia e dimensioni delle specie.				I fenomeni sono in progressione, ma non vi sono parti a rischio distacco							
2	CONSERVATIVA	1	2	3	2	CONSERVATIVA	1	2	3		
	FRUIBILITÀ	1	2	3		FRUIBILITÀ	1	2	3		
	ECONOMICA	1	2	3		ECONOMICA	1	2	3

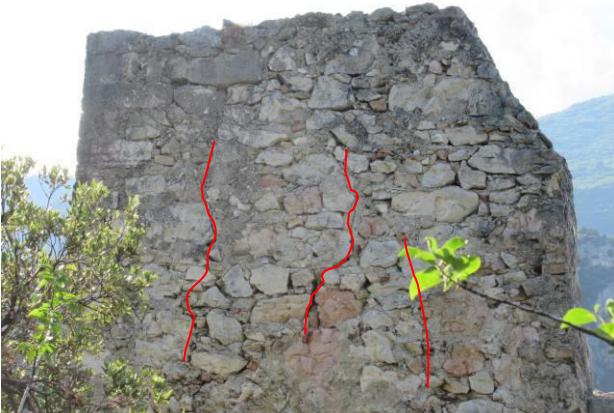
FESSURAZIONI			DIFFUSIONE							
			DESCRIZIONE

La muratura sulla sommità della parete presenta fessurazioni verticali parallele. Tali fessurazioni evidenziano la disgregazione strutturale di tale muratura alla quale deve essere correlata alla caduta di un blocco sul lato interno (vedi scheda 27).							
			ISTRUZIONI		Le fessurazioni devono essere sigillate.					
			DOCUMENTAZIONE		IMG_4545					
GRAVITÀ			URGENZA							
Il fenomeno che interessa la muratura sebbene localizzato risulta puntualmente grave in quanto questa muratura prospetta sul sottostante percorso aperto al pubblico.			Le pietre risultano non legate con possibilità di caduta delle medesime nell'immediato.							
3	CONSERVATIVA	1	2	3	3	CONSERVATIVA	1	2	3	
	FRUIBILITÀ	1	2	3		FRUIBILITÀ	1	2	3	
	ECONOMICA	1	2	3		ECONOMICA	1	2	3

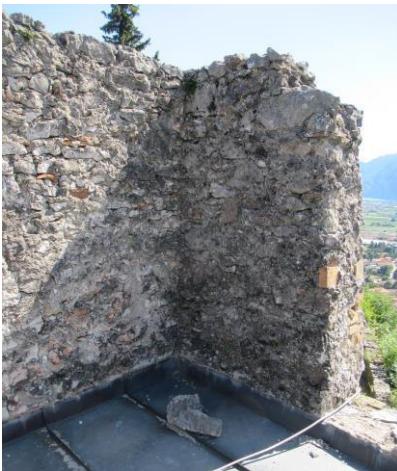
DISTACCO BLOCCHI CORONAM			DIFFUSIONE						
			DESCRIZIONE

La muratura del rialzo dello spigolo Sud-Ovest ha evidenziato la caduta di un blocco del coronamento che attualmente risulta depositato sulla copertura interna.						
			ISTRUZIONI		Il coronamento deve essere revisionato mediante creazione di una superficie di sacrificio che consenta di allontanare le acque meteoriche con sigillatura idonea dei giunti				
			DOCUMENTAZIONE		IMG_4498				
GRAVITÀ			URGENZA						
Il fenomeno è lo stesso segnalato nella scheda 27; sebbene localizzato risulta puntualmente grave in quanto questo spigolo prospetta sul sottostante percorso aperto al pubblico.			Le pietre del coronamento risultano sostanzialmente non legate con possibilità di imminente caduta delle medesime.						
3	CONSERVATIVA	1	2	3	3	CONSERVATIVA	1	2	3
	FRUIBILITÀ	1	2	3		FRUIBILITÀ	1	2	3
	ECONOMICA	1	2	3		ECONOMICA	1	2	3

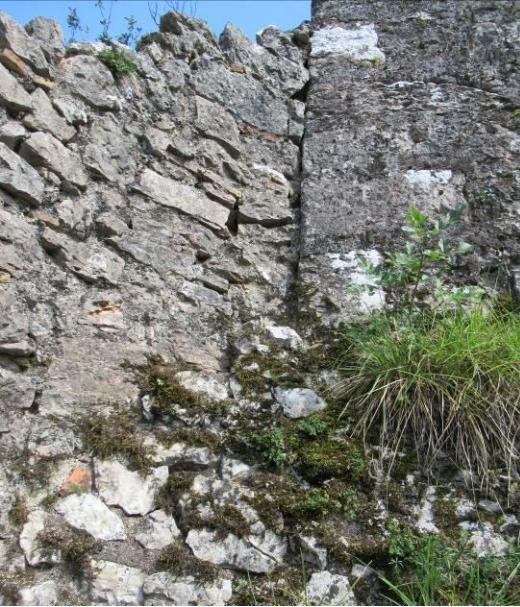
<p>Muratura la cui funzione è difficilmente interpretabile che spicca dallo spigolo Nord-Est della torre del Laghel nella posizione maggiormente strapiombante. Tale muratura non è ammorsata allo spigolo della torre (vedi immagine sopra). E' fondata direttamente sulla roccia affiorante ed a valle c'è una fune di acciaio trasversale, forse utilizzata per scopi manutentivi.</p> <p>La muratura è realizzata in pietra calcarea sbozzata con posa irregolare, angoli parzialmente costituiti da pietre squadrate e legata da malta di calce con inerti da millimetrici a centimetrici. La fugatura in malta di calce molto alta a creare una superficie regolare.</p> <p>Esposizione Nord-Sud</p>
Anno di realizzazione	Non noto
Documentazione fotografica ispezione	..\\0 Documentazione fotografica ispezione\Supporto 29

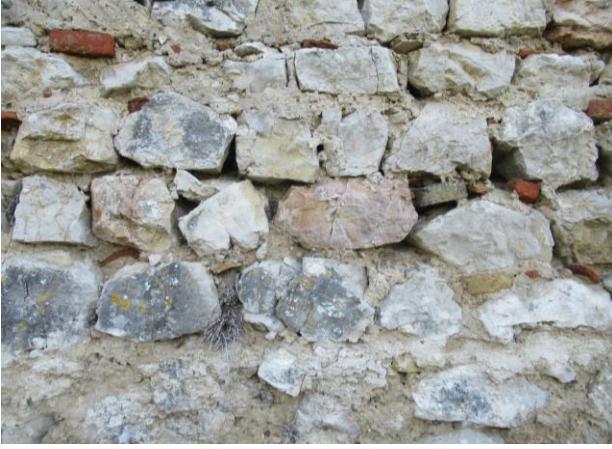
<p>Fenomeni di disaggregazione della malta nei giunti. Tali fenomeni non paiono attribuibili a movimenti attivi, ma possono rappresentare un problema in quanto costituiscono una via preferenziale per l'infiltrazione di acque meteoriche all'interno del corpo murario.</p>

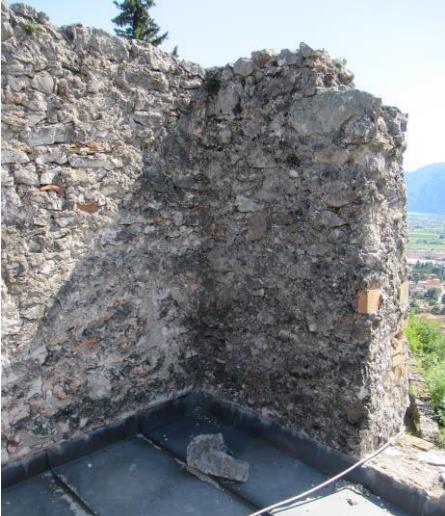
Il coronamento della muratura appare sensibilmente disgregato, con mancanza di malta nei giunti; alcuni blocchi risultano quindi poco o per niente ammorsati ed a rischio di caduta.

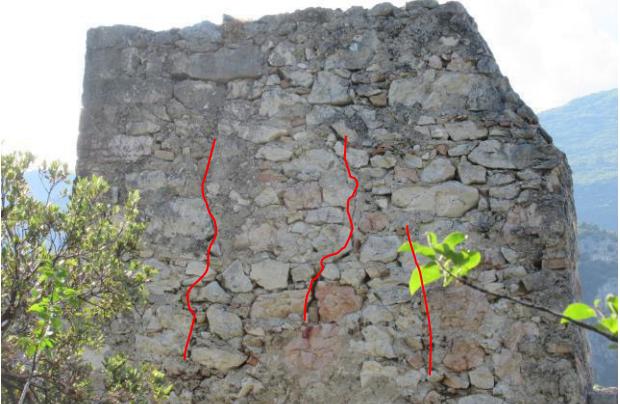
DANNO: FESSURAZIONI

Fessurazioni verticali parallele che evidenziano la disaggregazione strutturale della muratura.

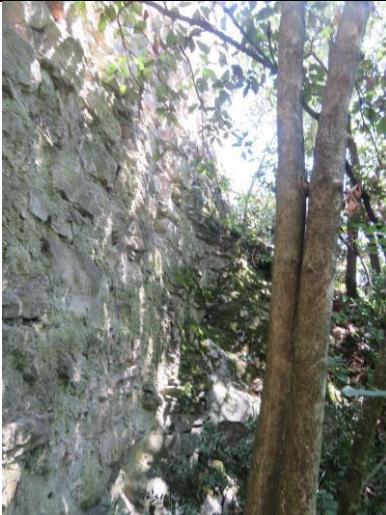
La presenza di vegetazione soprattutto di tipo arbustivo si localizza in particolare nei prospetti esterni al piede delle murature o direttamente negli interstizi murari. La vegetazione a portamento arbustivo crea disarticolazione delle murature per la crescita degli apparati radicali

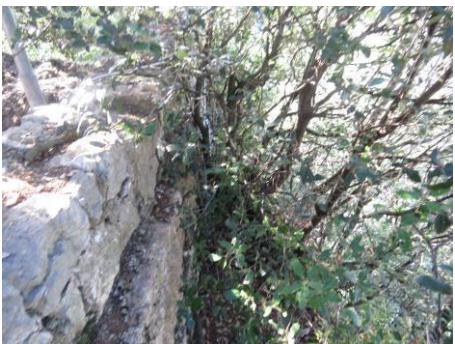
La presenza di vegetazione soprattutto di tipo arbustivo si localizza in particolare nei prospetti esterni al piede delle muratura dove il deposito di semi e terricci oconsente la formazione di arbusti.

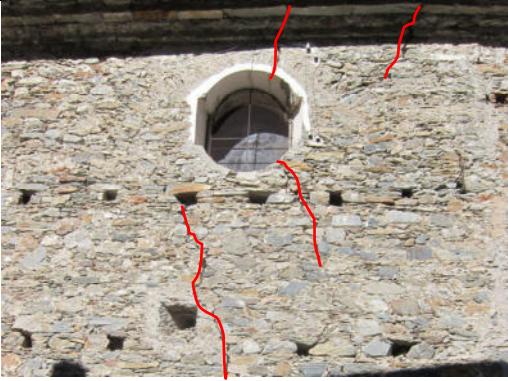
POSIZIONE	Prospetto sud-est ESTERNO	Rappresentazione	CODICE	FES_04	RIF. FOTO	Descrizione				
			Elemento	muro	pilastro	solaio	volta	trave

Tipologia	<input checked="" type="checkbox"/> fessura	<input checked="" type="checkbox"/> sistema fessurativo					
			Sviluppo	<input type="checkbox"/> vert	<input checked="" type="checkbox"/> subvert	<input type="checkbox"/> orizz	<input type="checkbox"/> suborizz	<input type="checkbox"/> 45°		
			Apertura	<input type="checkbox"/> submillim.	<input type="checkbox"/> 1÷2mm	<input type="checkbox"/> 2÷5mm	<input type="checkbox"/> 5÷10mm	<input checked="" type="checkbox"/> >10mm		
			Passante	<input type="checkbox"/> no		<input checked="" type="checkbox"/> si (corrispondenza con				
			Gravità	Bassa	Media	Alta				
			Urgenza	1	2	3

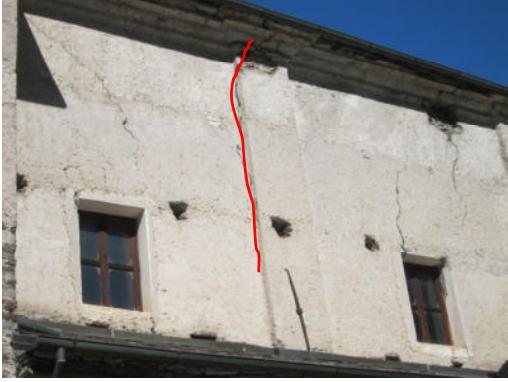
POSIZIONE	Prospetto sud-est ESTERNO	Rappresentazione	CODICE	FES_06	RIF. FOTO	Descrizione				
			Elemento	muro	pilastro	solaio	volta	trave

Tipologia	<input checked="" type="checkbox"/> fessura	<input checked="" type="checkbox"/> sistema fessurativo					
			Sviluppo	<input checked="" type="checkbox"/> vert	<input type="checkbox"/> subvert	<input type="checkbox"/> orizz	<input type="checkbox"/> suborizz	<input type="checkbox"/> 45°		
			Apertura	<input type="checkbox"/> submillim.	<input type="checkbox"/> 1÷2mm	<input type="checkbox"/> 2÷5mm	<input checked="" type="checkbox"/> 5÷10mm	<input type="checkbox"/> >10mm		
			Passante	<input checked="" type="checkbox"/> no		<input type="checkbox"/> si (corrispondenza con				
			Gravità	Bassa	Media	Alta				
			Urgenza	1	2	3

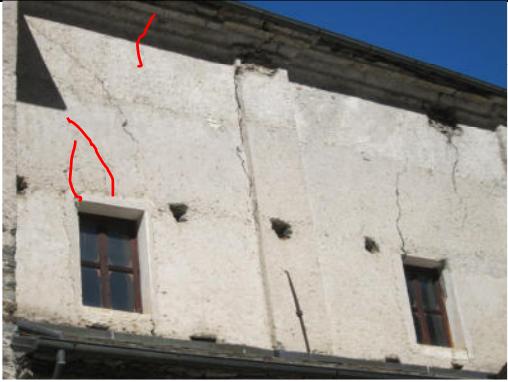
POSIZIONE	Prospetto sud-est ESTERNO	Rappresentazione	CODICE	FES_07	RIF. FOTO	Descrizione				
			Elemento	muro	pilastro	solaio	volta	trave

Tipologia	<input type="checkbox"/> fessura	<input checked="" type="checkbox"/> sistema fessurativo					
			Sviluppo	<input type="checkbox"/> vert	<input checked="" type="checkbox"/> subvert	<input type="checkbox"/> orizz	<input type="checkbox"/> suborizz	<input type="checkbox"/> 45°		
			Apertura	<input checked="" type="checkbox"/> submillim.	<input type="checkbox"/> 1÷2mm	<input type="checkbox"/> 2÷5mm	<input type="checkbox"/> 5÷10mm	<input type="checkbox"/> >10mm		
			Passante	<input checked="" type="checkbox"/> no		<input type="checkbox"/> si (corrispondenza con				
			Gravità	Bassa	Media	Alta				
			Urgenza	1	2	3
