Methodology CHANGES

Town hall Oirschot

Monument Diagnosis and Conservation System

Raadhuis (Town hall) CHANGES, Markt 1, 5688 AJ Oirschot, The Netherlands

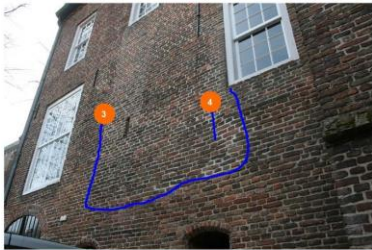
Exterior wall, first floor, north facade

3 Deformation 1st floor near window

Date	Damage type(s)	Comment
14-05-2016	1	Preliminary visual inspection (inspectors SN, HAH)

4 Cracks in northern wall near deformation

Date	Damage type(s)	Comment
14-05-2016	1	Preliminary visual inspection (inspectors SN, HAH) The load bearing wall shows damage symptoms which might be related and indicate an underlying structural problem
