# CHANGES PROJECT – The role of FMeA

# Foppoli Moretta e Associati consulting engineers

The project will be carried out in two areas in the northern and in the southern part of Lombardia: the territory of Valtellina and the town of Cremona

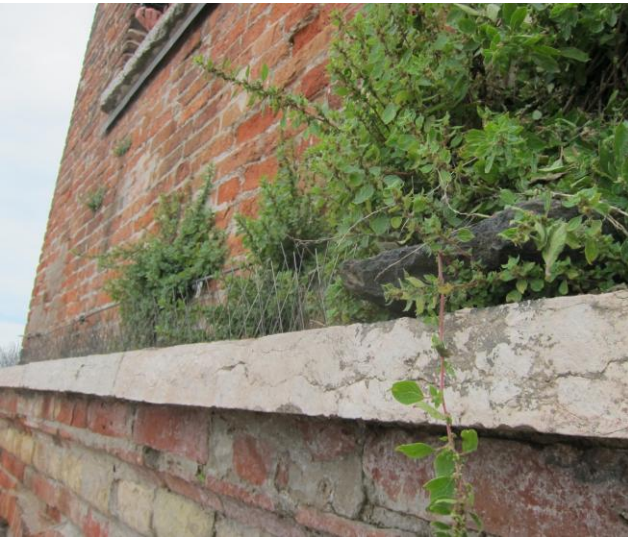
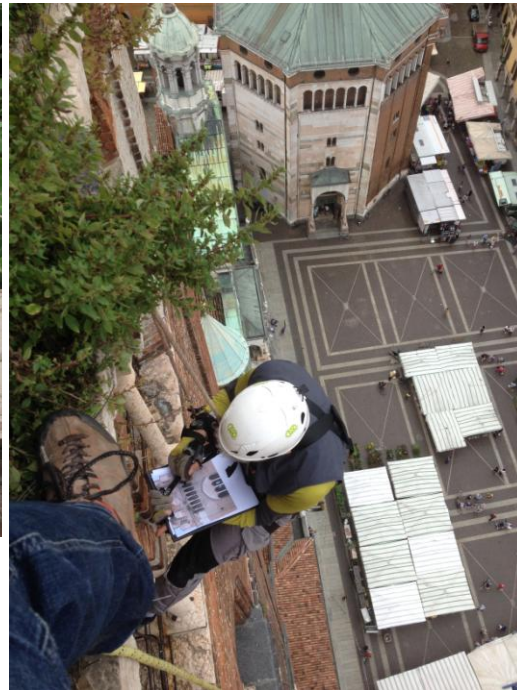
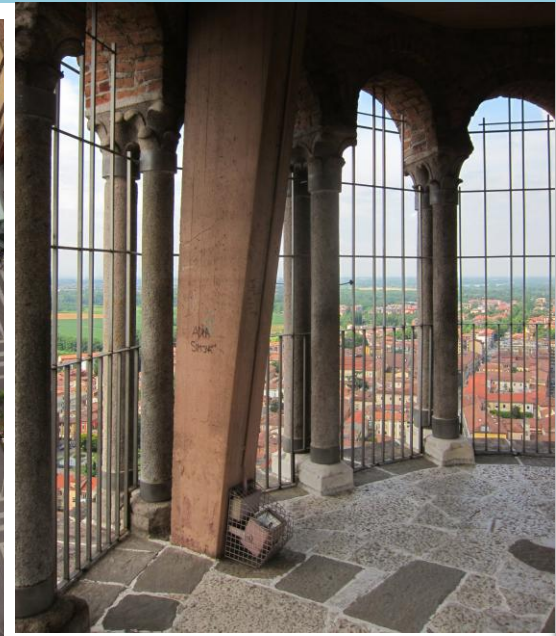
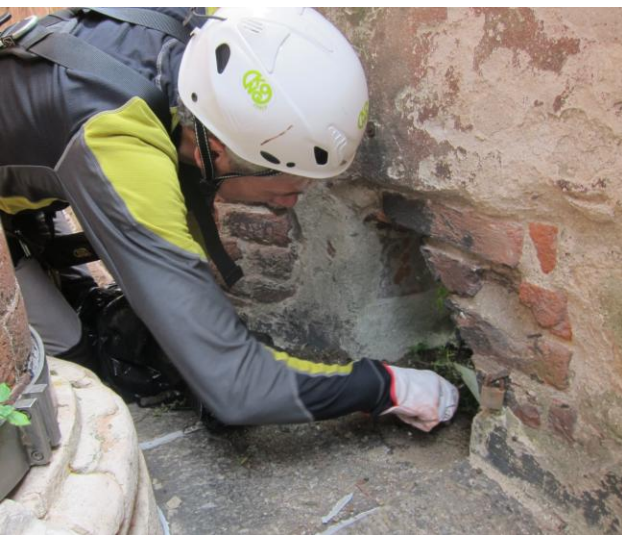
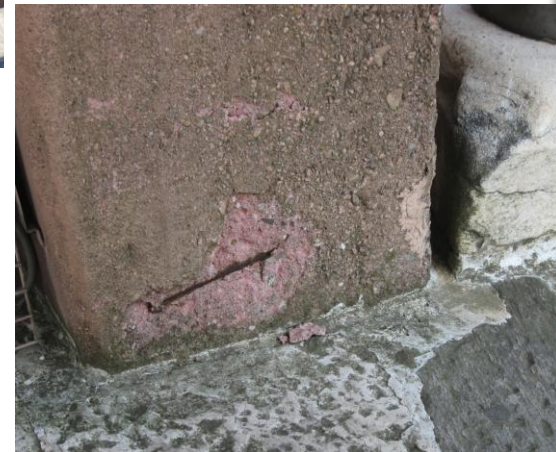
# Activities in progress - Cremona - Torrazzo

Next week it was performed an inspection on the top of Cremona main bell tower (called Torrazzo) with access and positionign techniques by ropes

The growth of vegetation at the top of the tower is mainly caused by lack of maintenance of the gargoyles. There are also significant decayments of the top concrete structure

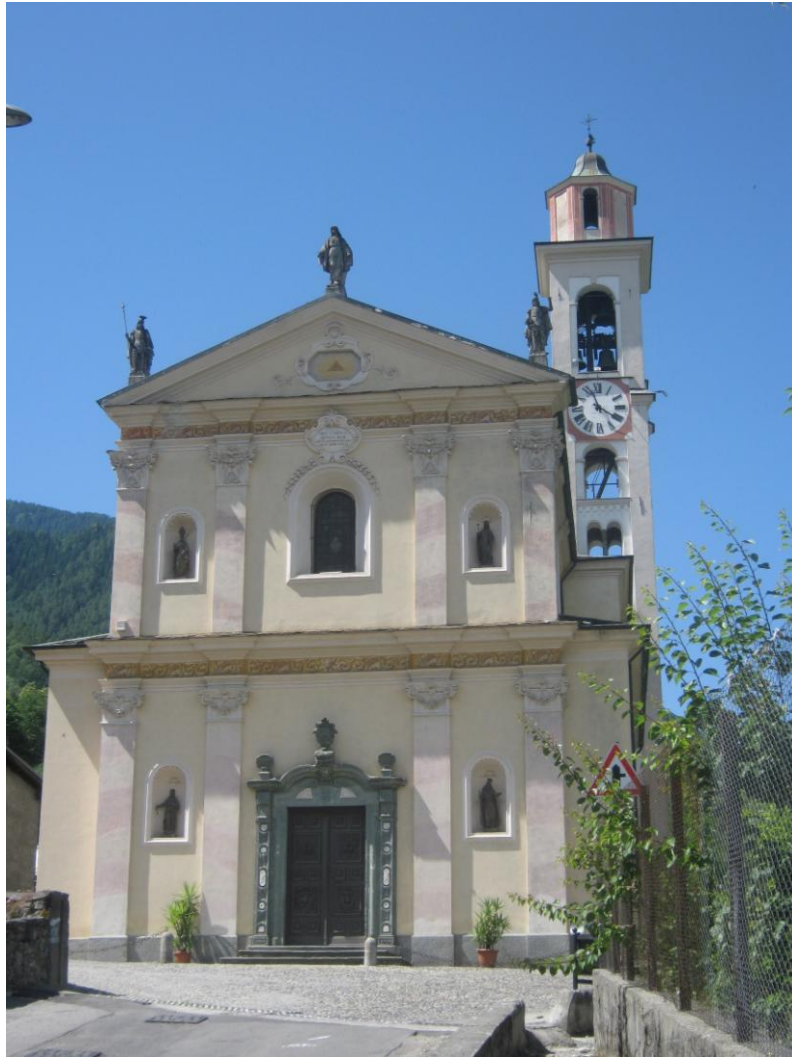
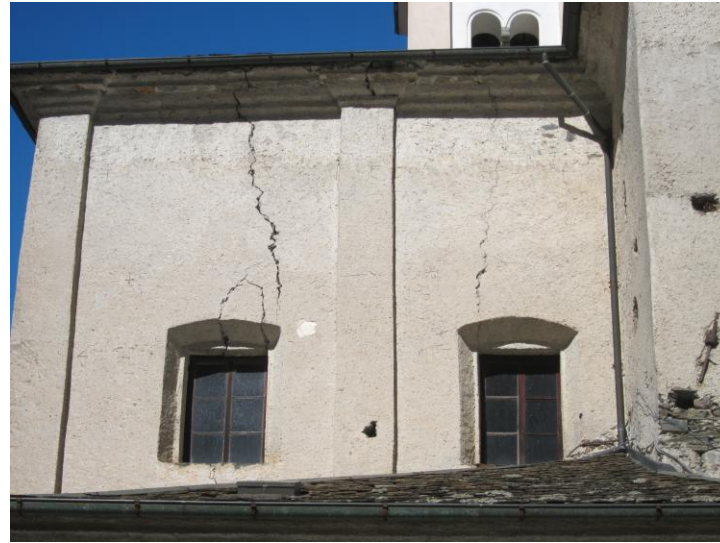
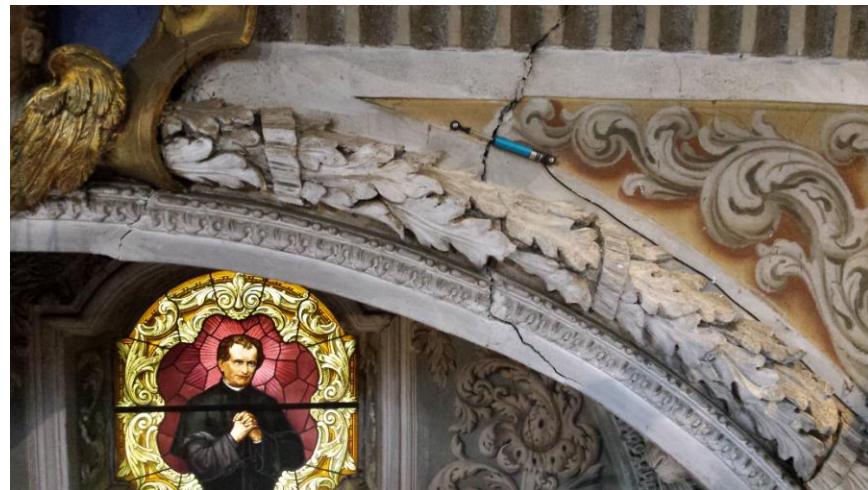
# Activities in progress – Valtellina - Lovero

S. Maria church in Lovero displays a wide crack pattern:  
it was installed a structural monitoring system of the
