# CHANGES - Changes in Cultural heritage Activities: new Goals and benefits for Economy and Society

***International Conference***  
***CULTURAL HERITAGE MANAGEMENT:***  
***CONSERVATION AND VALORISATION IN AN***  
***INTEGRATED PERSPECTIVE***  
***VILLA REALE, MONZA - 2016, May 26***

**Dario Foppoli**  
**Foppoli Moretta e Associati**  
consulting engineers  
Tirano (SO) – ITALY  
[posta@foppolimoretta.it](mailto:posta@foppolimoretta.it)  
[www.foppolimoretta.it](http://www.foppolimoretta.it)

**THE EXPERIENCE OF VALTELLINA CULTURAL DISTRICT**

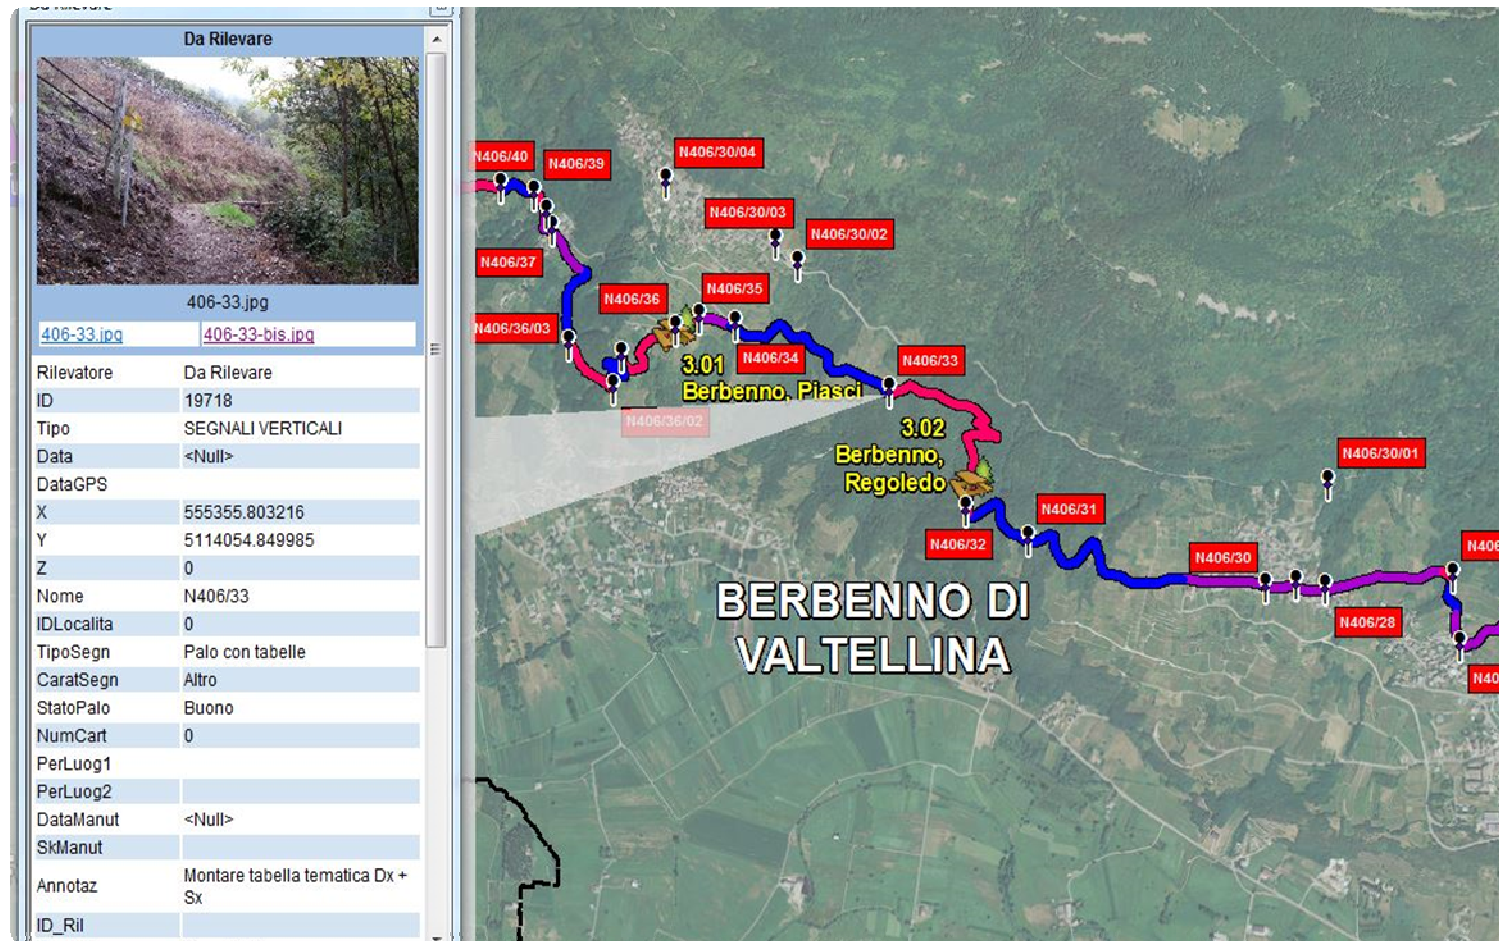
MAINTENANCE PLAN WITH GIS TECHNIQS, ALLOWS:

- TO HAVE INFORMATION AVAILABLE ON TRACK WITH A TOUCH
- TO KEEP THE PATH UNDER CONTROL
- TO MAP COMPLETELY THE REST AREAS
- TO CREATE DIRECT REPORT OF MAINTENANCE ACTIVITIES

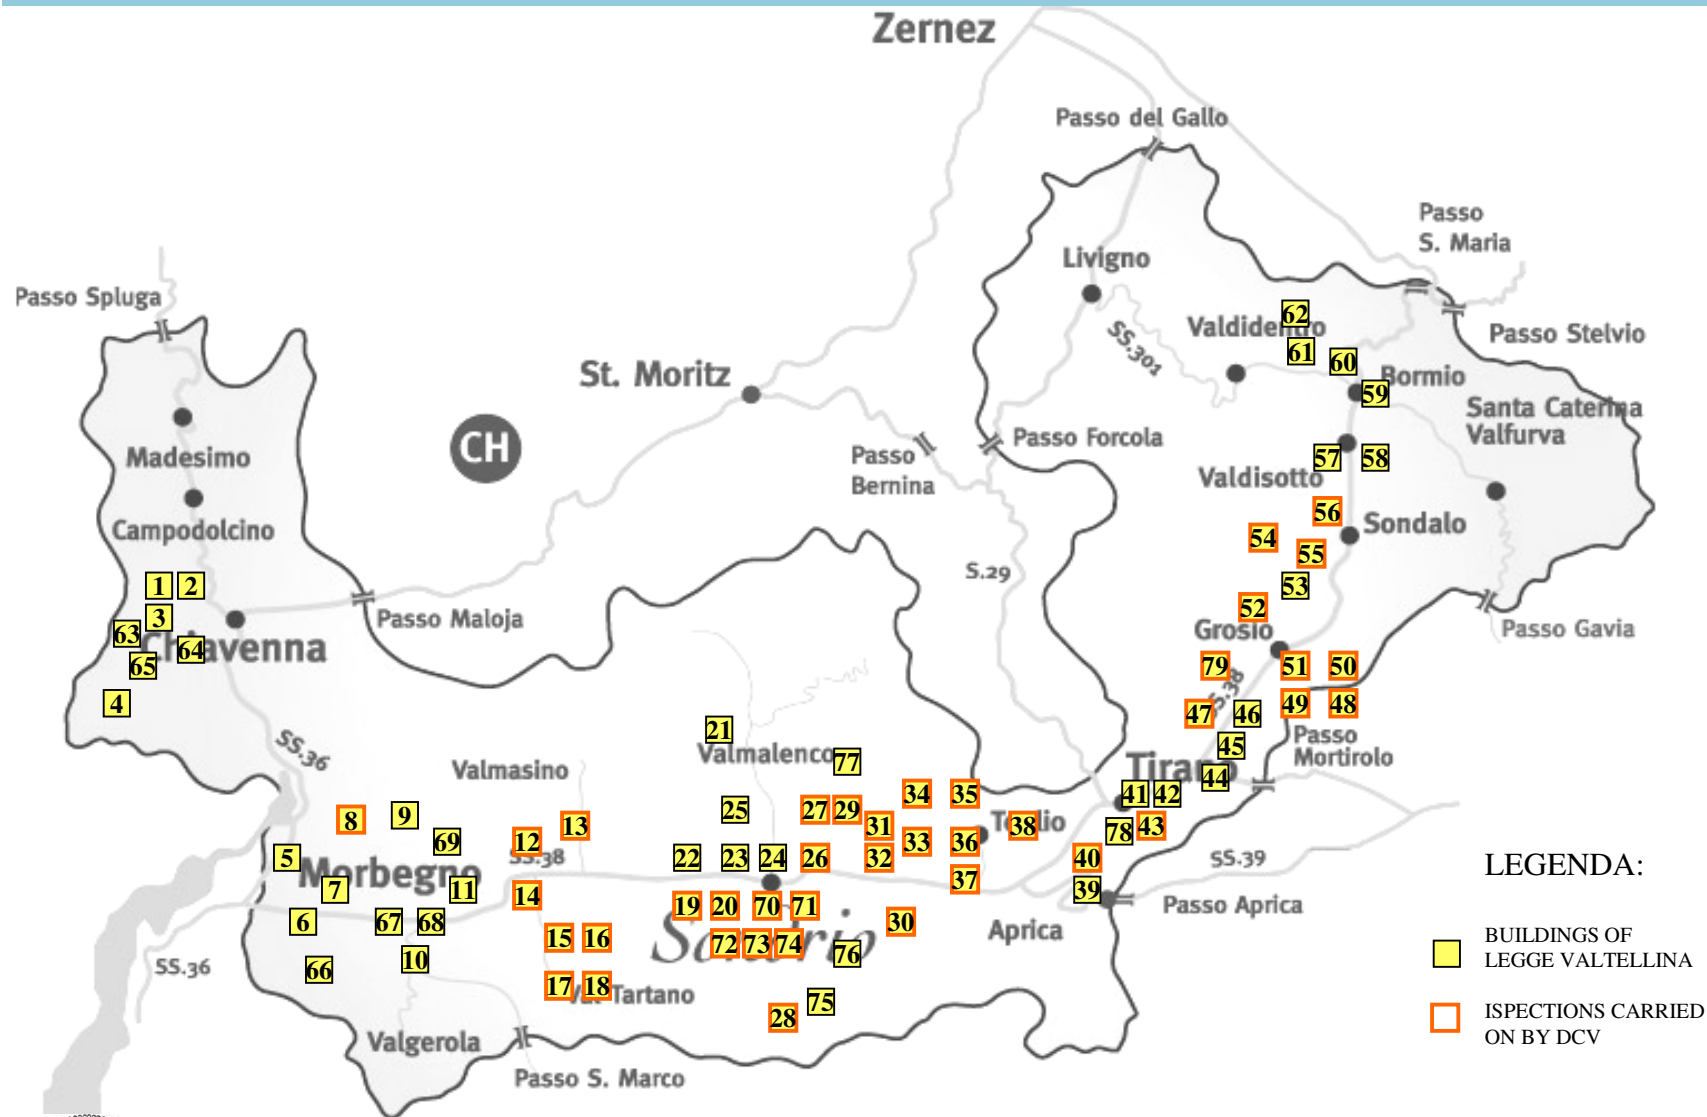
INSPECTION FOR THE ANALYSIS OF THE CURRENT STATUS OF HERITAGE  
BUILDINGS RESTORED AFTER 1987 FLOOD. (**40 BUILDINGS**)

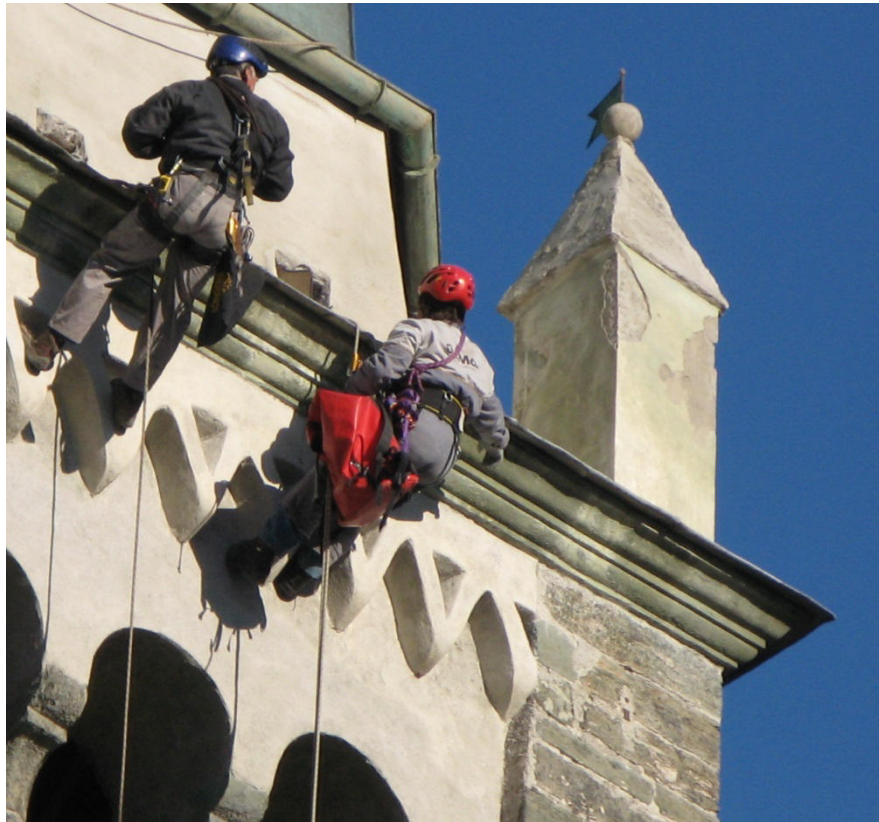
CLOSE INSPECTIONS USING VISUAL SURVEYS  
FROM THE GROUND, WITH THE USE OF MOBILE  
PLATFORMS AND ALSO WITH THE USE OF ROPES

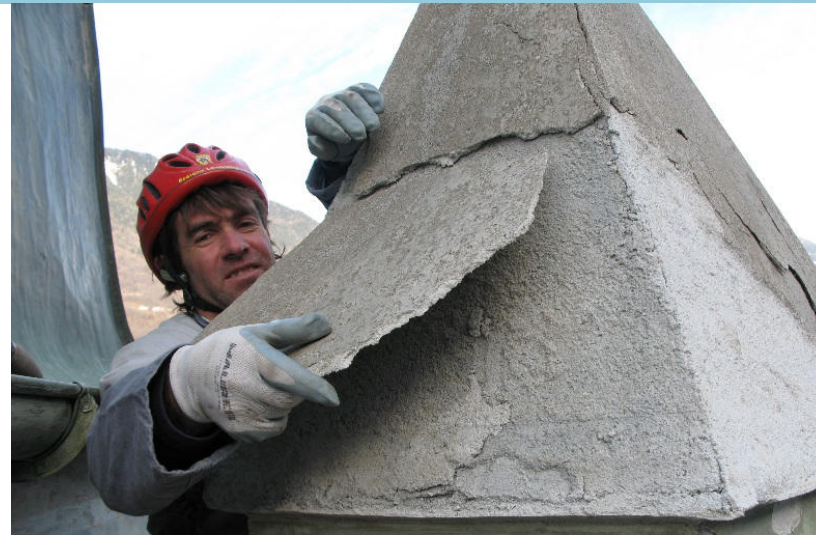
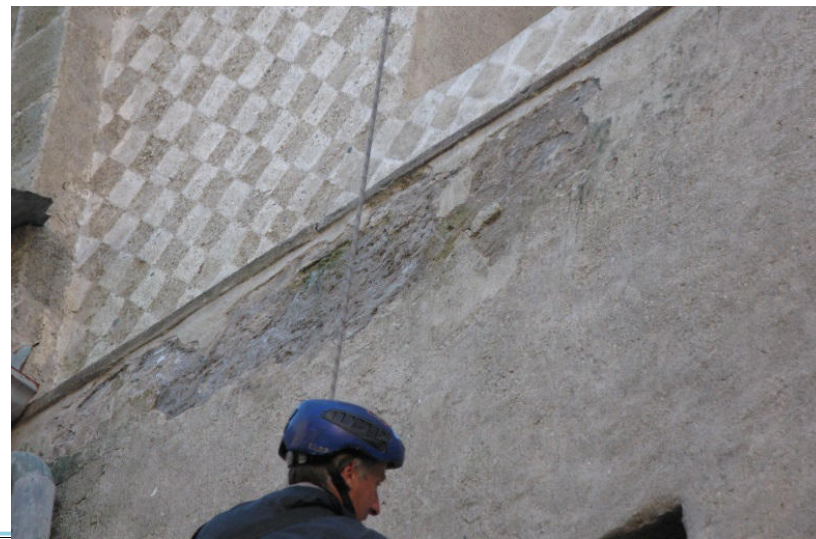
**SAFETY IMPROVEMENT BY REMOVING DETACHED ELEMENTS**  
**VERIFICATION OF FUNCTIONALITY AND STATE OF CONSERVATION**

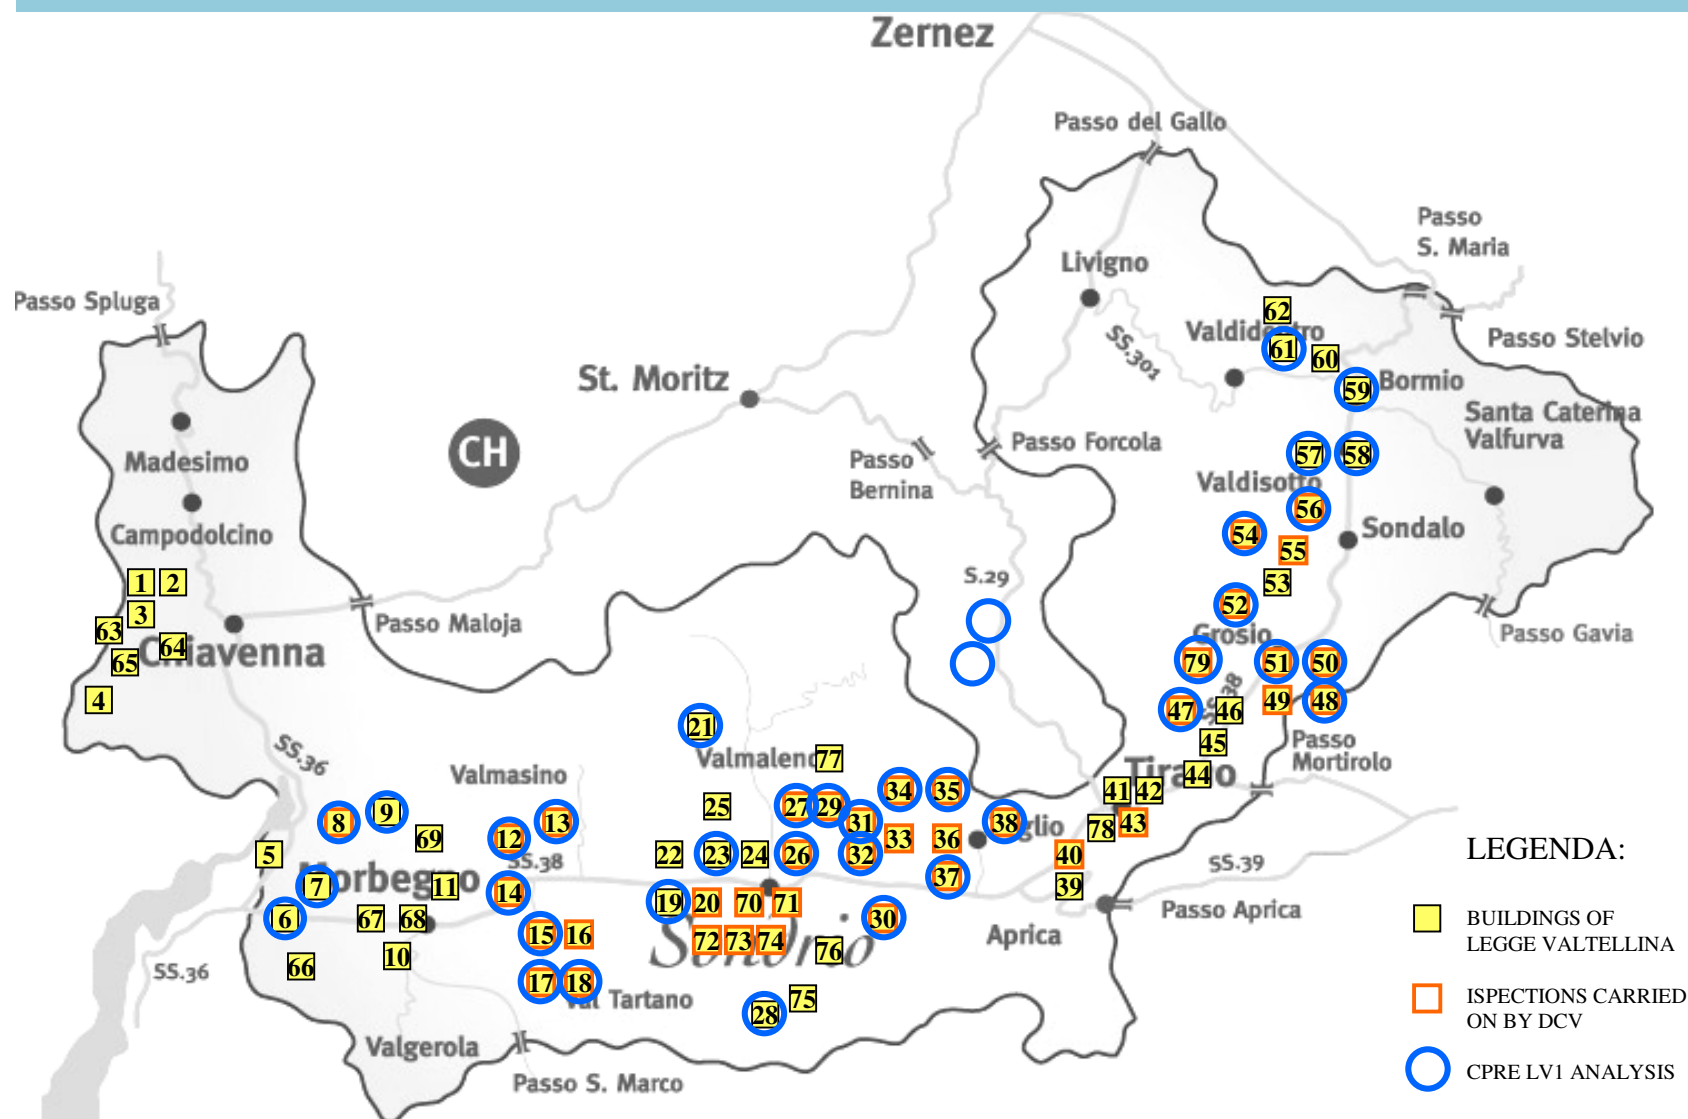
- BUILDINGS OF LEGGE VALTELLINA
- ISPECTIONS CARRIED ON BY DCV
- CPRE LV1 ANALYSIS

PREVENTIVE SEISMICAL ASSESSMENT OF HERITAGE BUILDINGS  
RESTORED AFTER 1987 FLOOD. (**36 BUILDINGS**)

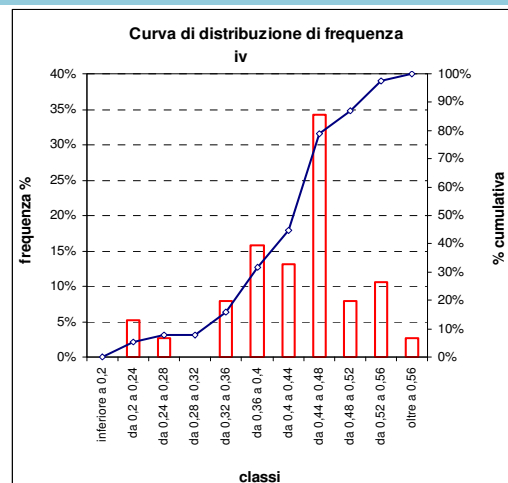
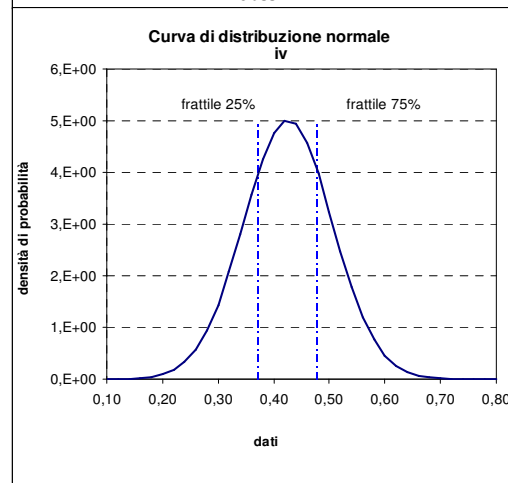
Vulnerability Index  $I_v$

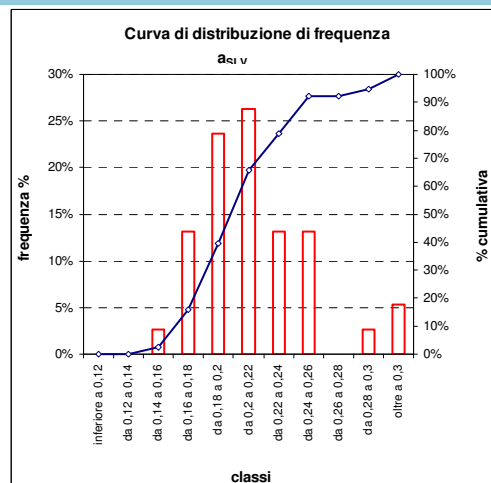
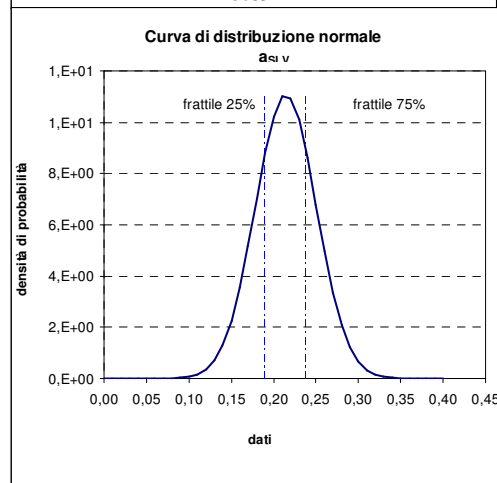
Ground acceleration associated  
with the Life safety L. S.  $a_{SLV}$

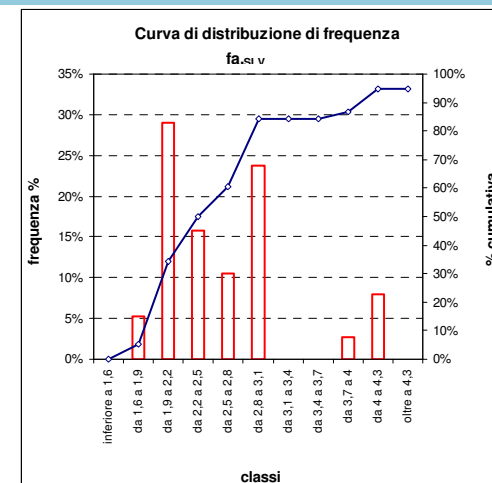
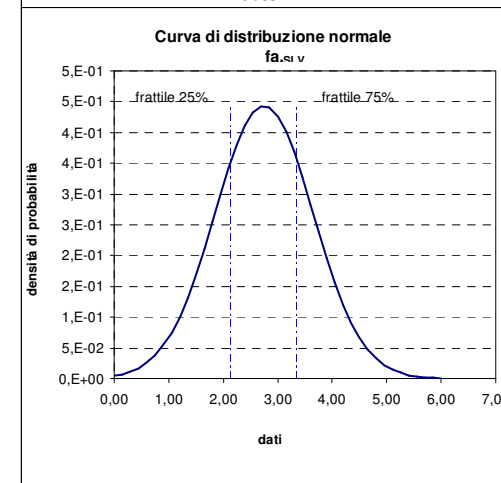
Acceleration factor associated  
with the Life safety  $f_{aSLV}$

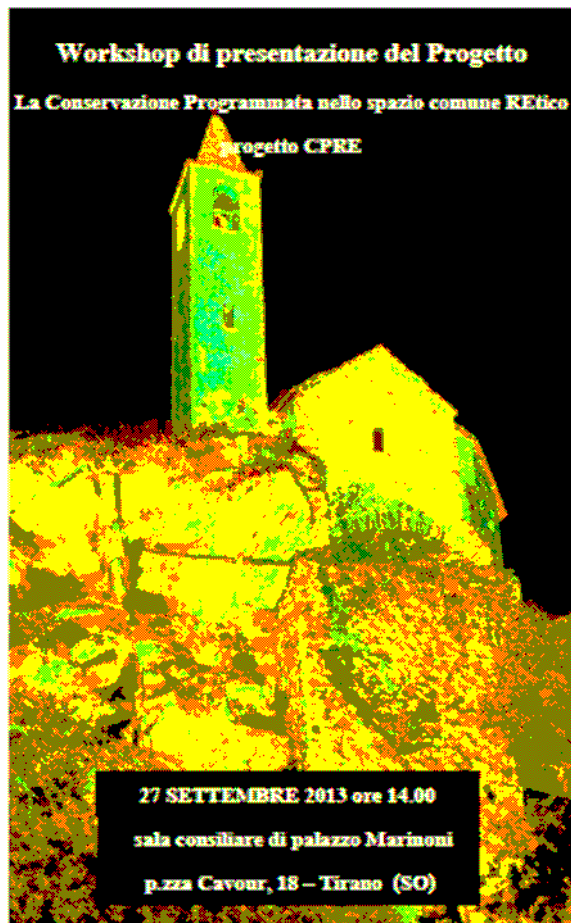
Scansione laser-scanner chiesa di S. Romero - Brusio
