THE IMPORTANCE OF A MONUMENTENWACHT SYSTEM

THE SITUATION
IN NORTH-BRABANT

Rob van Hees, Silvia Naldini & Timo Nijland

**Delft University of Technology - Faculty of Architecture and the Built Environment
Department Architectural Engineering + Technology
Section Heritage & Architecture**

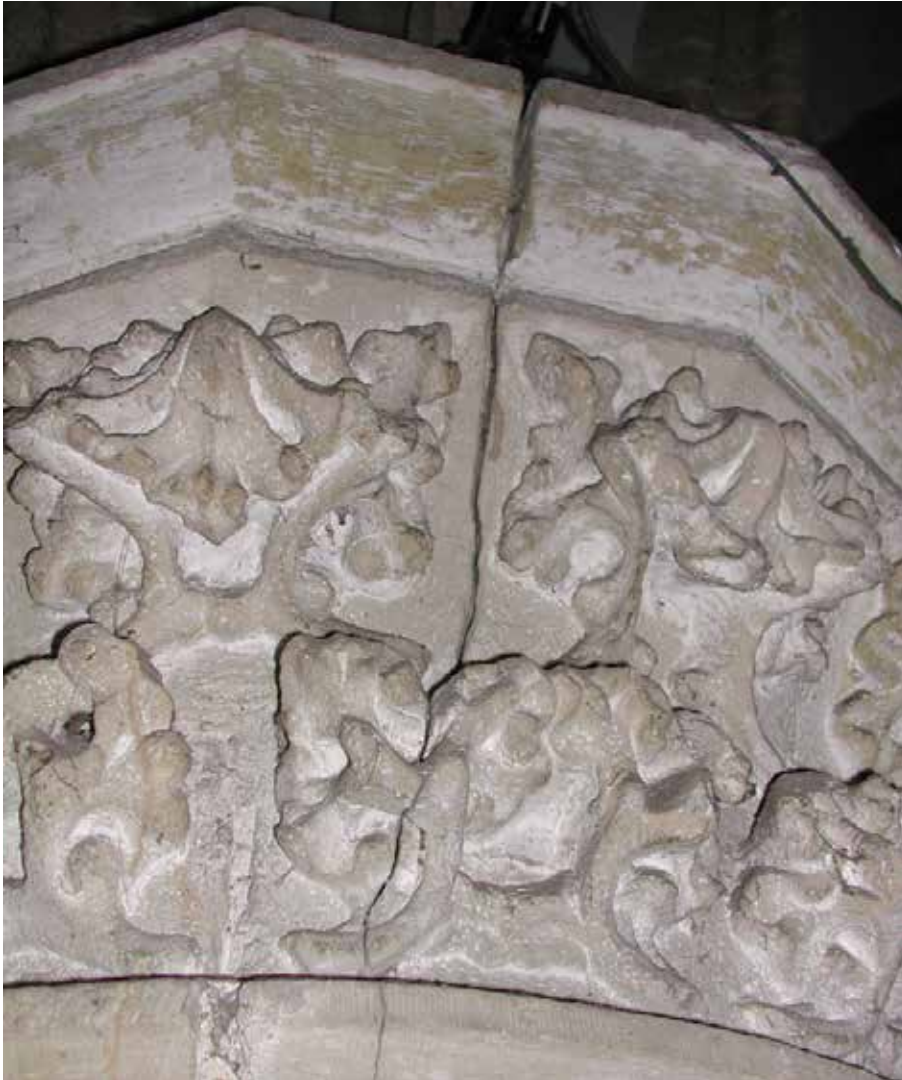
Figure 3.1.1 Cracked capital, which might lead to a dangerous situation

In this context we need to think of loose natural stone elements (fig. 3.1.1, 3.1.2, 3.1.3), loose roof tiles, but also loose parts of masonry, concrete and the like, that in case of falling might endanger the occupants of the building or the public. And finally, structural problems such as related to the anchoring of rafters to walls belong to this category.

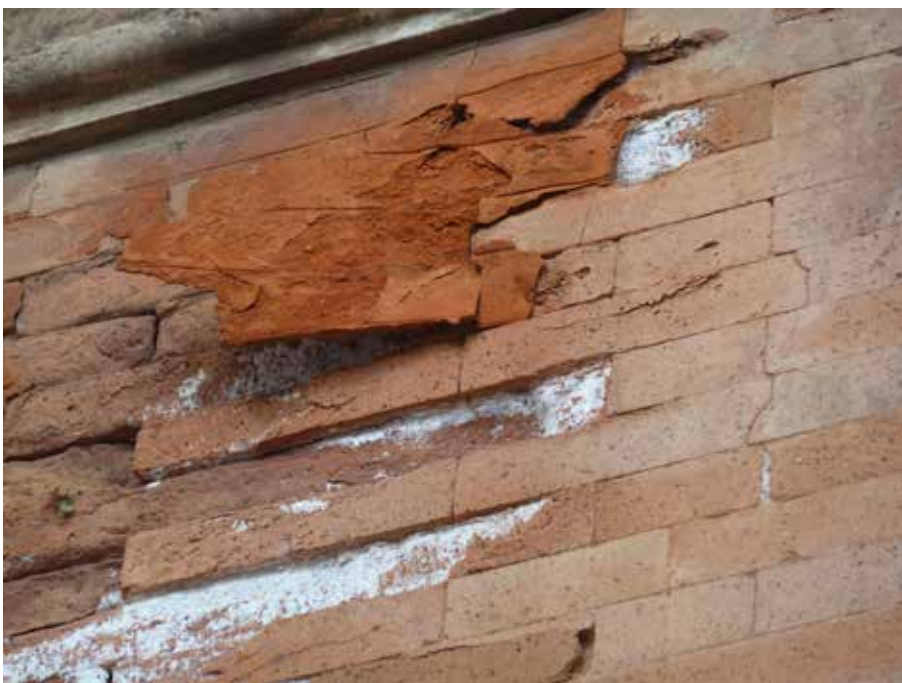
Figure 3.1.2 Loose parts of masonry, posing potential danger for passers-by

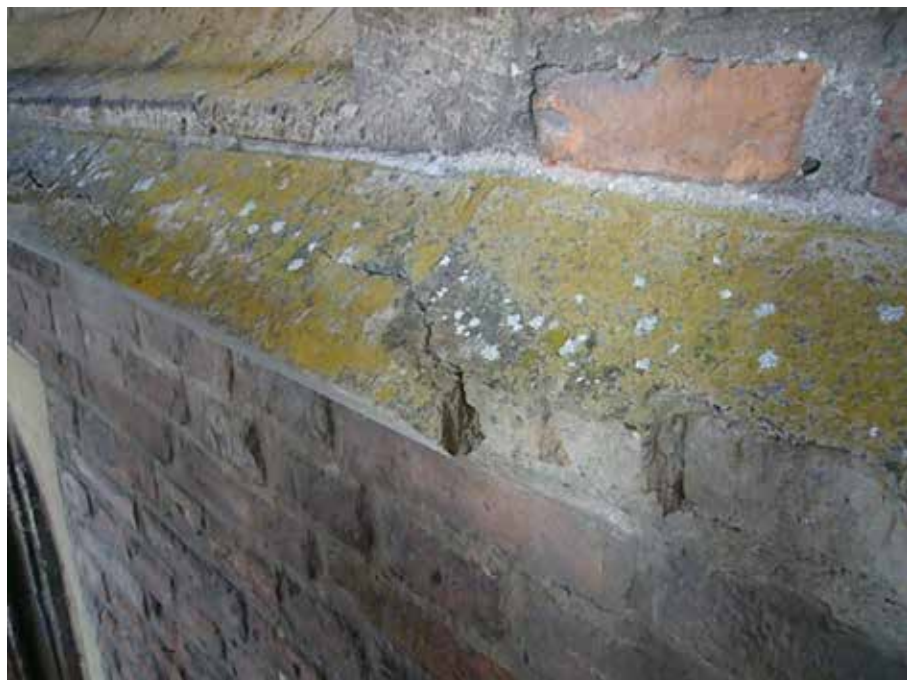
Figure 3.1.3 Loose part of a tuff stone cornice, in case the façade faces a public path there is acute danger for passers-by

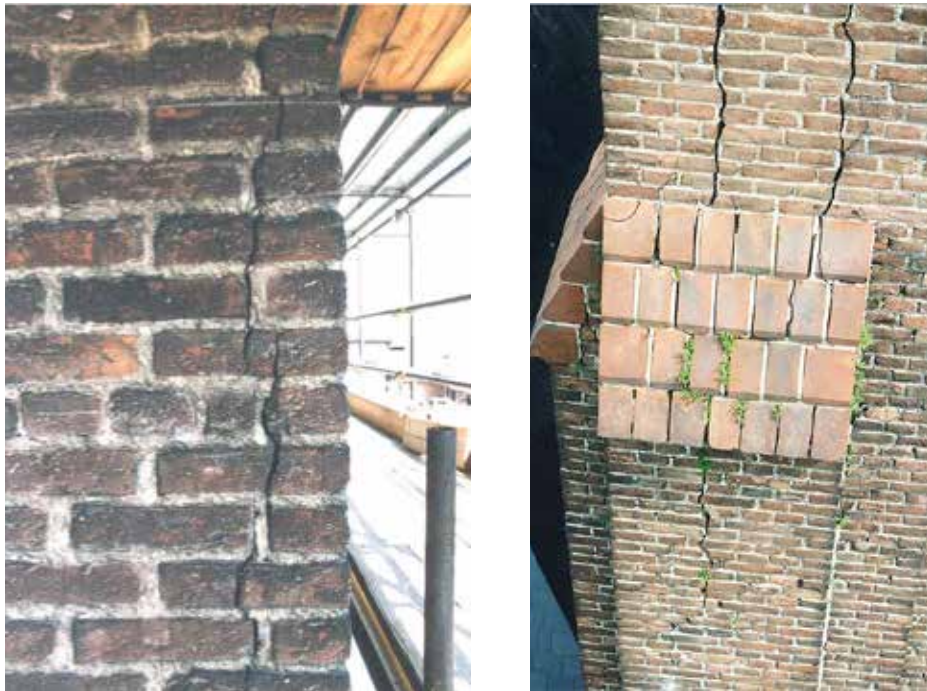
Figure 3.1.4 Comparable crack patterns. In the left case (detail of a tower in Italy) it was a structural problem that led to the tower collapsing. In the right case, laboratory investigations showed that the cracks resulted from a swelling reaction in the bedding mortar, used for the masonry behind the visible brick layers: a nasty problem, how-ever without the risk of collapse

tural problem: see fig. 3.1.4. In such cases better be safe than sorry, meaning we have to consider acute danger. Another area where the role of MW is of great importance.

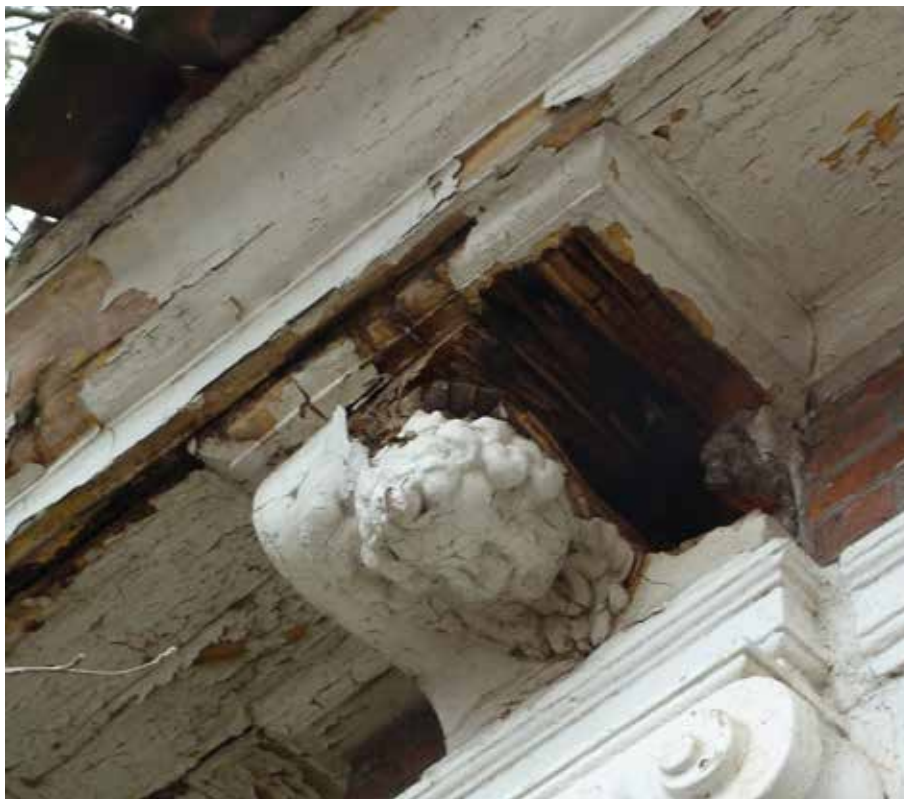
Figure 3.2.1 Moisture led to wood rot and loss of material of the console

In general, most leakage and moisture related problems can be counted to the category of medium to long-term problems. They include problems with the paintwork (fig. 3.2.1), problems with joints of roofs and gutter, problems with joints at roof apertures, leaking roof gutters and roof covering, structurally weak roof construction caused by leakage and wood rot, wrong detailing at the connection of roof and gutter, wood moisture, and moisture and salt problems (fig. 3.2.3).

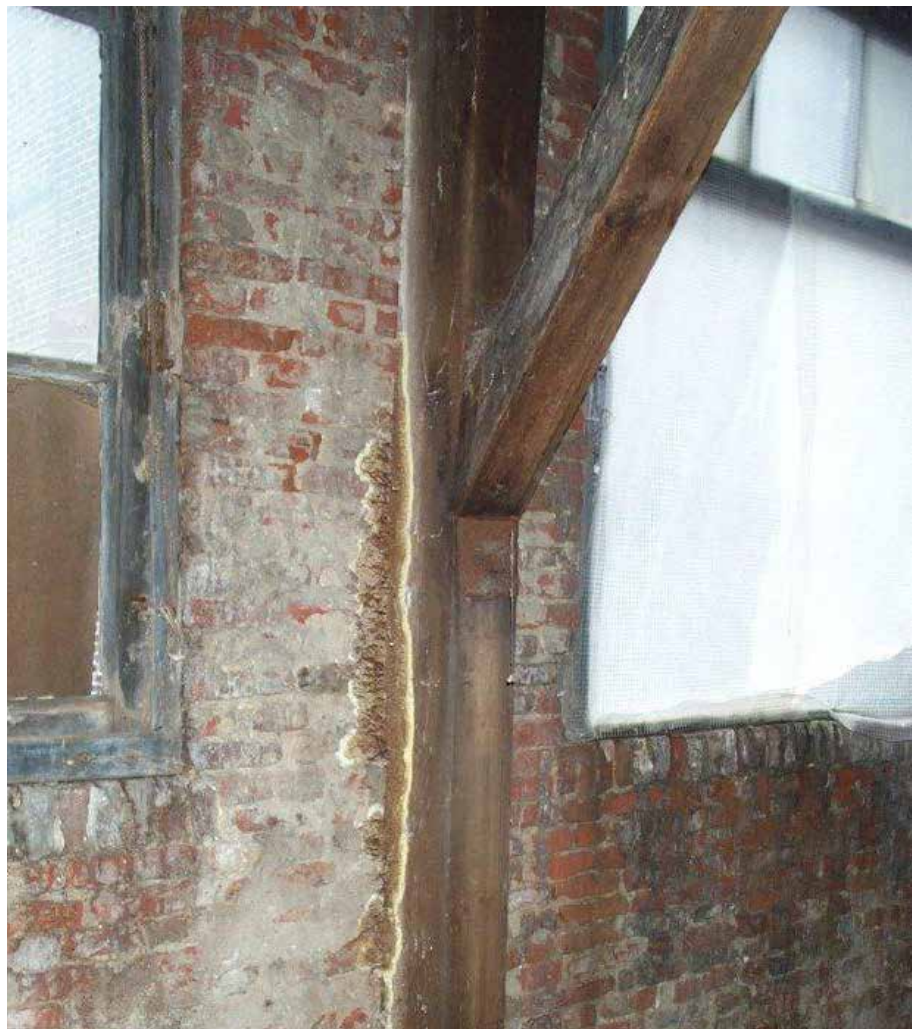
Figure 3.2.2 Infestation of the wooden wall baluster through dry rot fungus, as a result of long-term exposure of the wood to water penetration. The consequence is that in this case the entire wood construction had to be removed ('worst case')

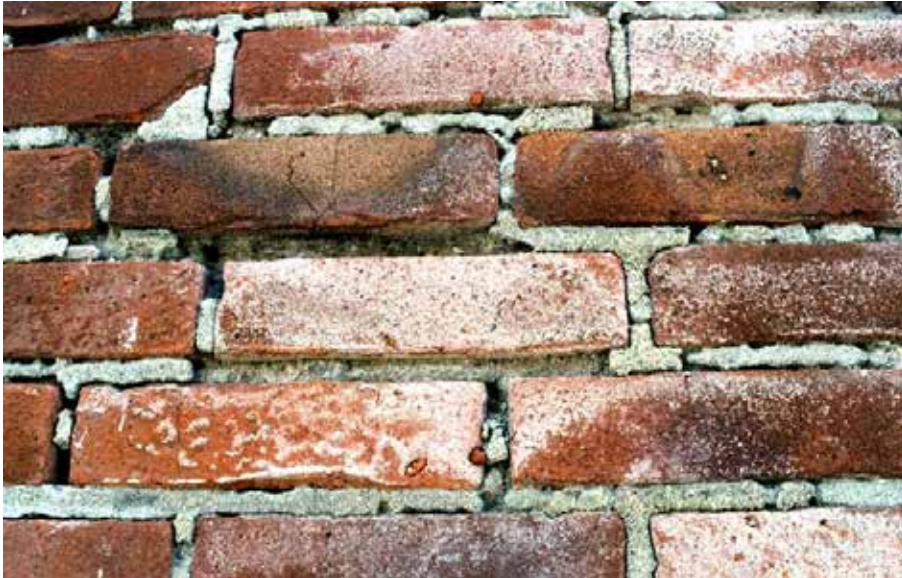
Figure 3.2.3 Moisture and salt problem, resulting in damage to pointing mortar and bricks

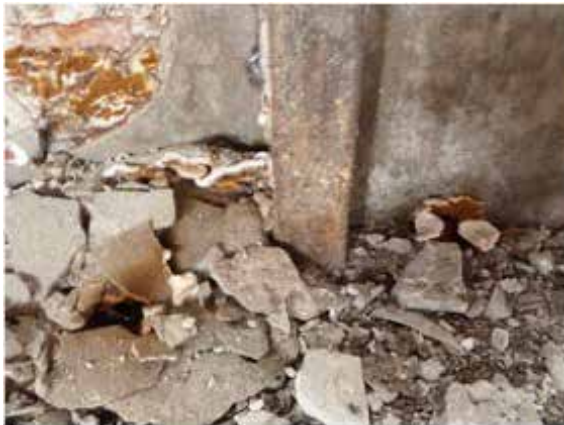
Figure 3.2.4 Dry rot fungus, spread between the plasterwork and the underlying masonry

In case of dry rot fungus, by the way, the necessary intervention must usually be much more comprehensive than dealing with the affected part alone.

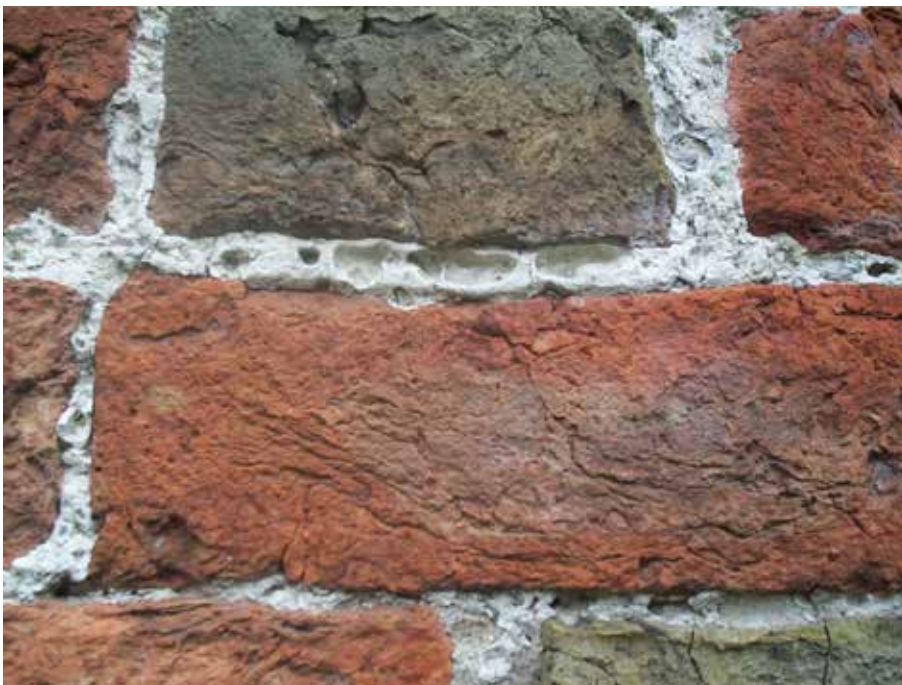
Figure 3.3.1 Alveolisation

Figures 3.3.1 – 3.3.4. The problems with brickwork joints (and bedding mortar), with various underlying causes and different consequences, c. q. different need for intervention.

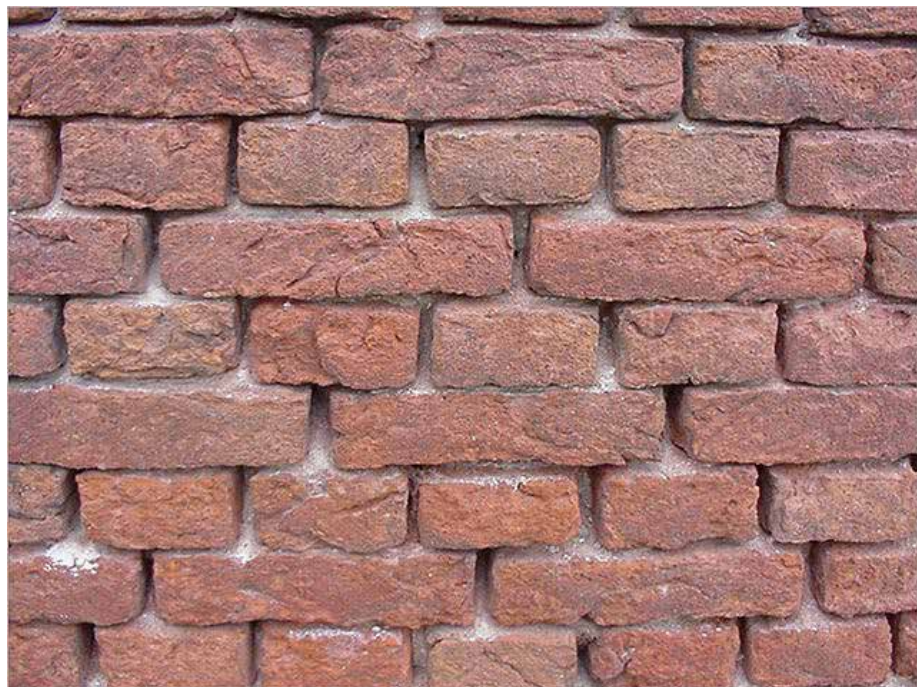
Figure 3.3.2 Sanding

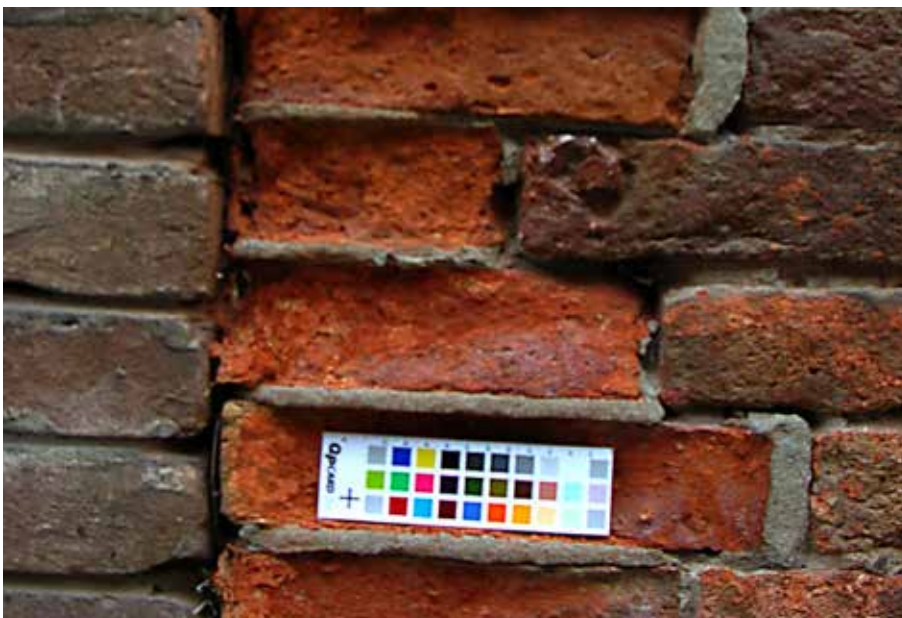
Figure 3.3.5 Incompatible re-pointing, resulting in accelerated damage to the brick

- » *Delayed drying of the historic masonry and eventual frost damage of the bedding mortar. Hereby the repaired joints are pushed out, the bedding mortar crumbles, and the brickwork can bulge. Or:*
- » *Too quick degradation of the stone whereby the joint itself remains intact; this is a case of incompatible pointing (composition), see fig. 3.3.5.*

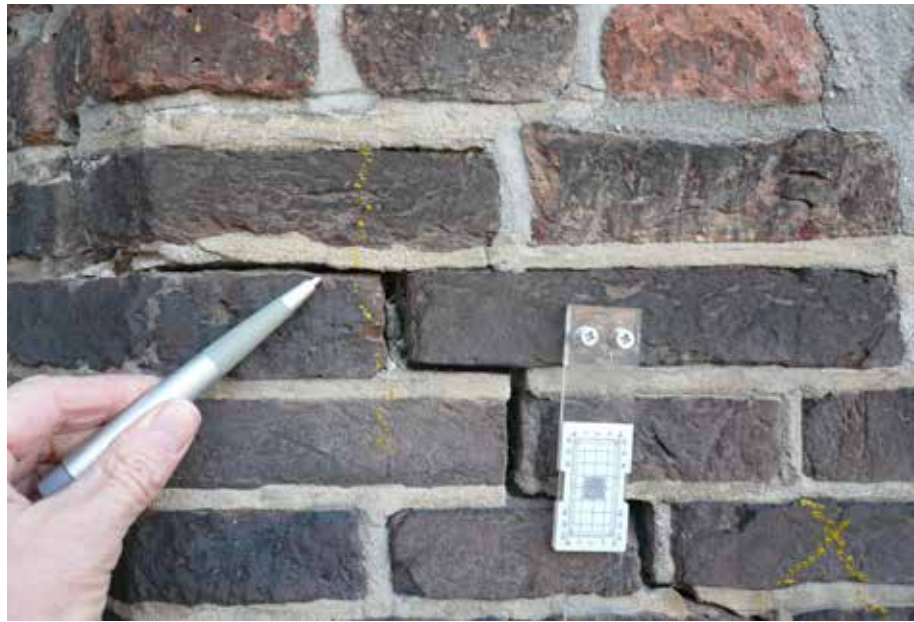
Figure 3.4.1 Crack formation in masonry and monitoring of masonry. It is important to determine whether it is a foundation related or other structural problem and also whether settlement still occurs

With these types of problems, it is usually a question of cracks and deformation. The value of MW hereby lies in the early pointing out and then monitoring of the problem. But it can also be about pointing out potentially dangerous situations (fig. 3.4.2), that require closer inspection since they might well lead to the situations described under 3.1.

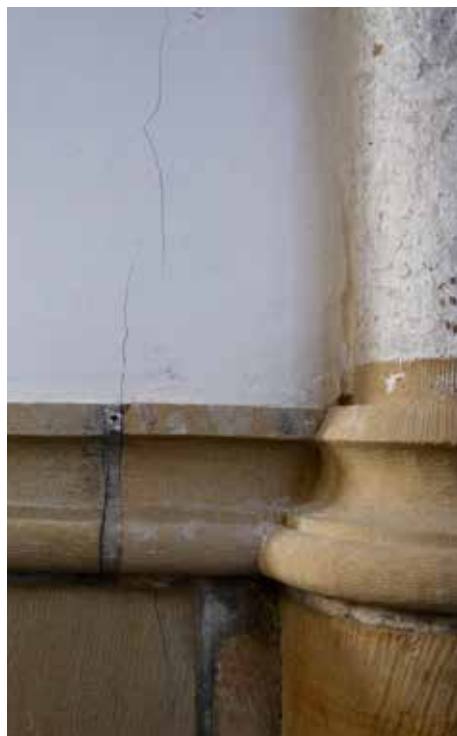
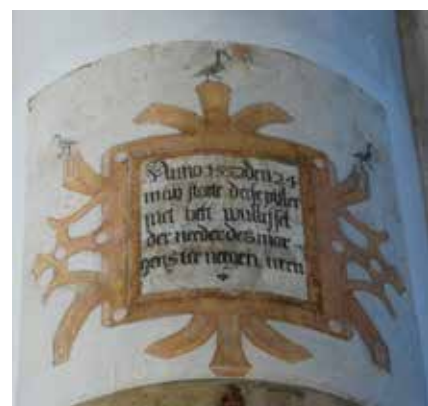
Figure 3.4.2 Crack forming in a church column: is this a long-term problem or a problem that requires immediate intervention. The inscription in the nearest column is food for thought: "Anno 1552 den 24 may storte deese pijler met het wulffsel der needer des morgens ter negen uren" (On 24 May 1552, at nine o'clock in the morning this column collapsed).

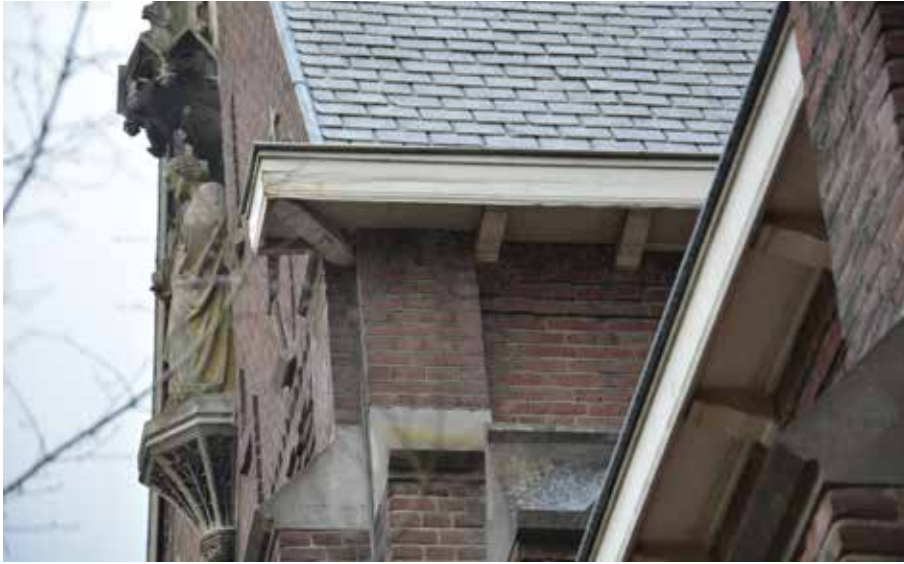
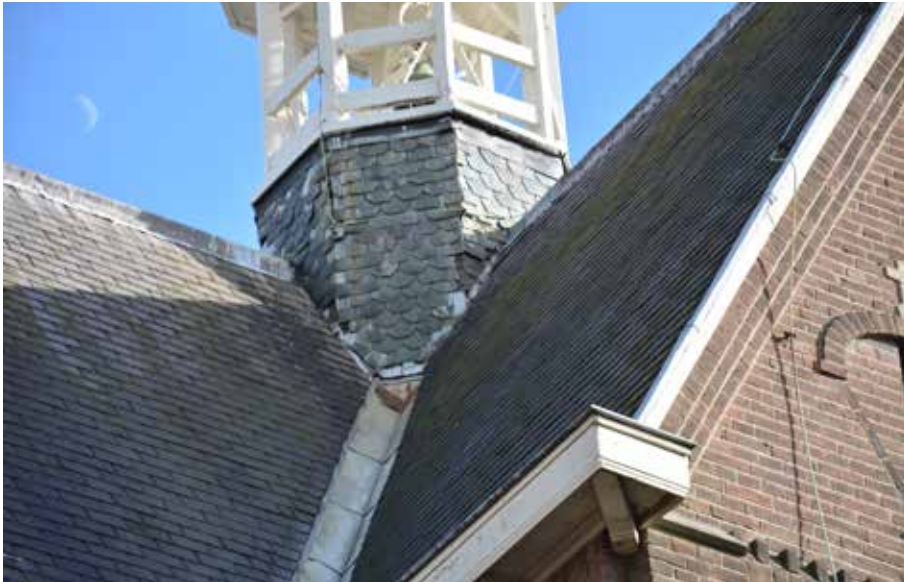
Figure 4.1.1 a/b Overdue maintenance of the chapel identified by the inspection of MW: paintwork in bad condition, wood rot, missing slate tiles

This chapel is from 1925. MW has found many (serious) damage types; the most important being:

Moisture related problems. These are defects that can lead to further moisture related problems such as missing parts of the slate roof covering, overdue paintwork on the roof gutter construction and possibly wood rot.

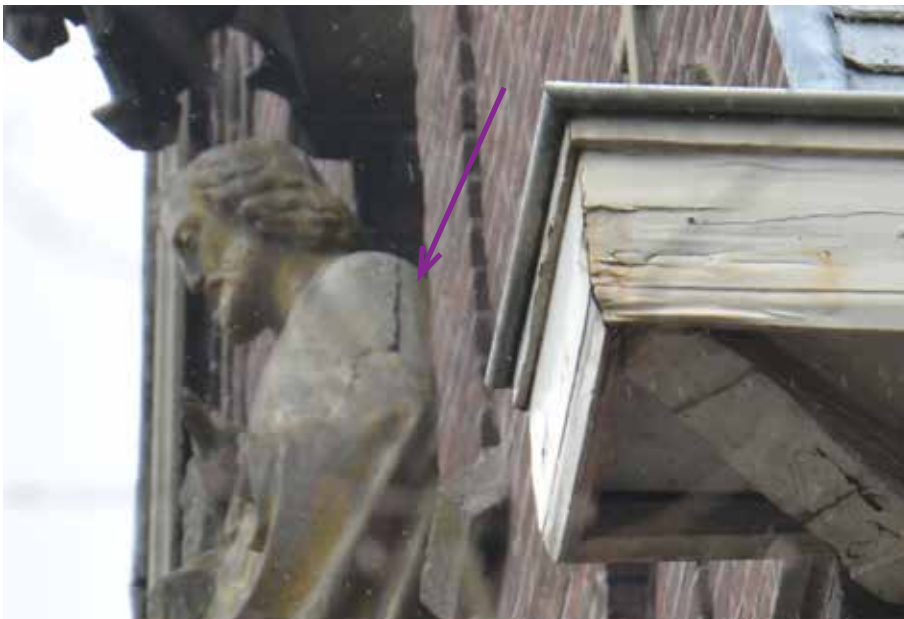
Figure 4.1.2 a The sculpture clearly shows a crack

Also the woodwork of the roof gutter is in bad condition (fig. 4.1.2.a), requiring maintenance and possible partial replacement.

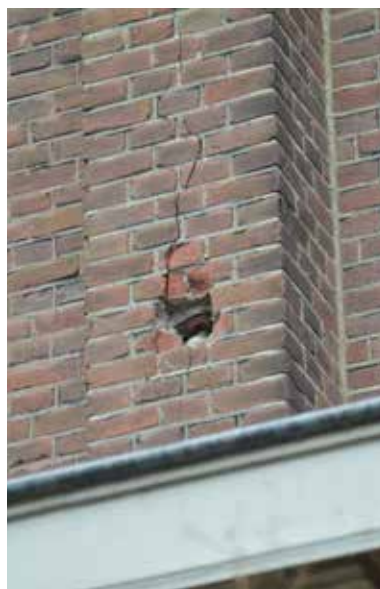
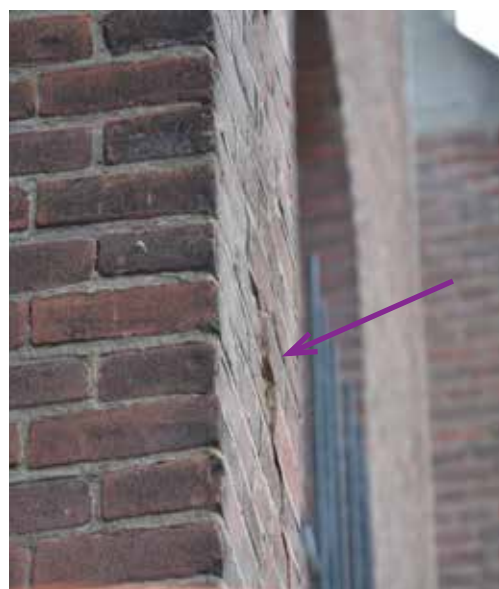
Figure 4.1.2b The photo shows a buttress with a piece of masonry that came loose, making visible a rusting anchor. Figure 4.1.2c The photo shows that here as well a piece of masonry is getting loose and being pushed out. Both cases show a potentially dangerous situation

Cracking as a possible consequence of rusting iron in masonry walls.

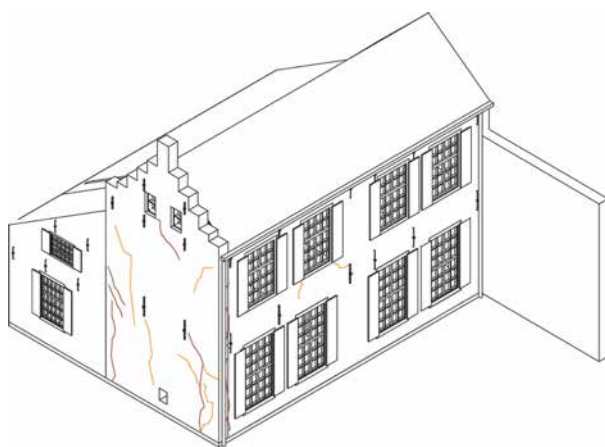
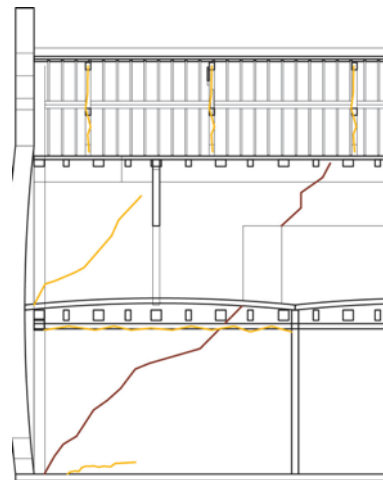
Figure 4.3.1 Old and new crack patterns in an end façade (l) and cracks in a load-bearing inner wall (r); (drawings from a student report, June 2015 [5])

The main problems relate to the construction: crack patterns and walls being out of plumb as well as moisture (mainly leakages). See fig. 4.3.1 through 4.3.3.

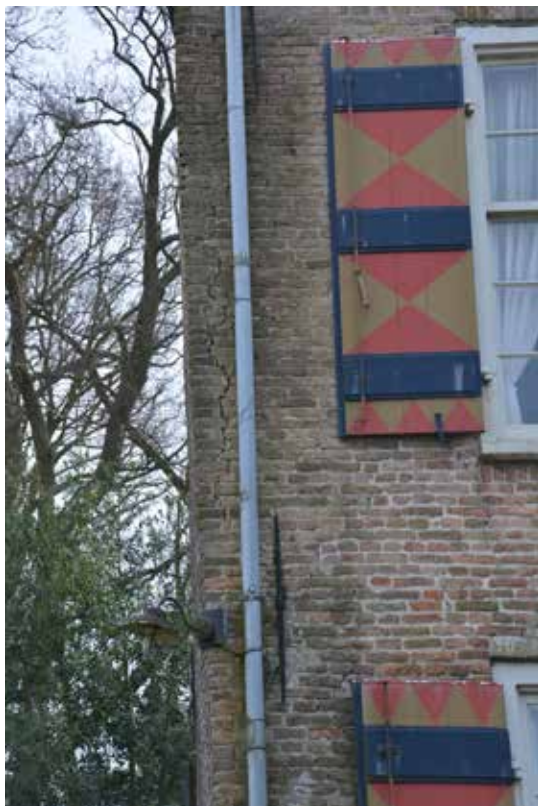
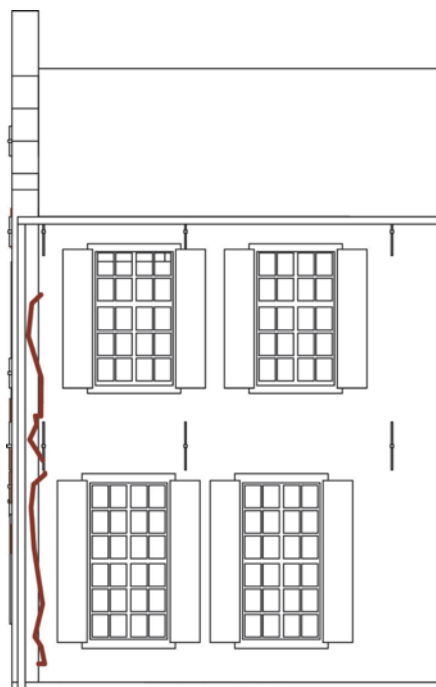
Figure 4.3.2 Long crack at the connection of a side and an end facade (drawing from a student report, June 2015) [5]

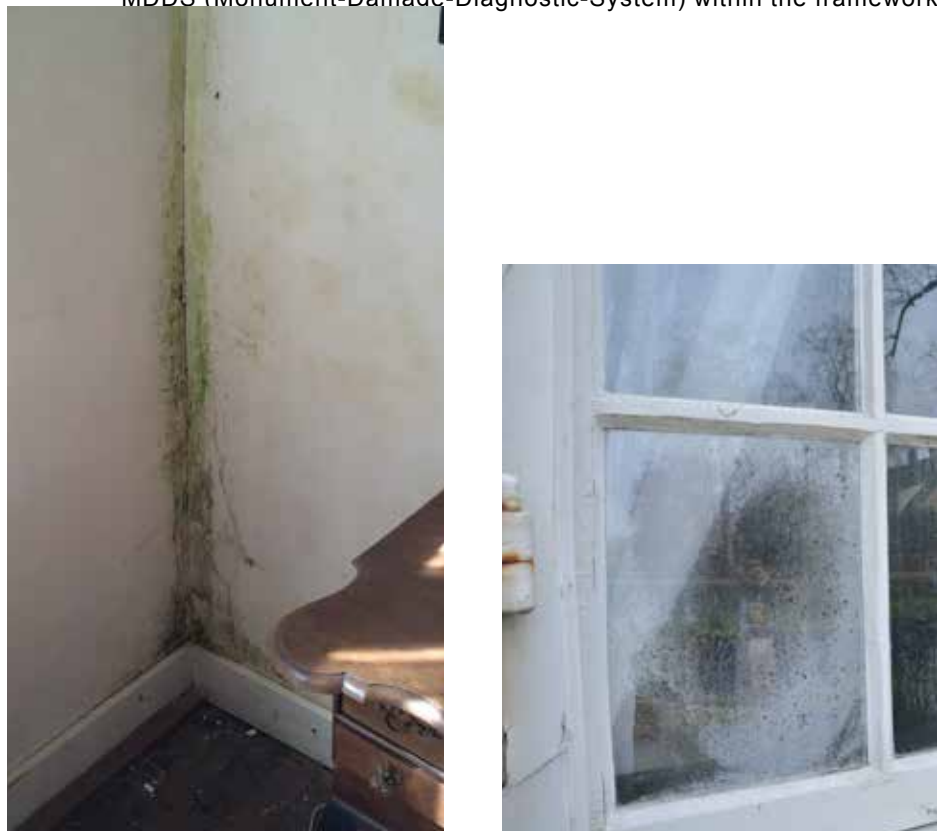
Figure 4.3.3 Moisture-related problem on the inside of the façade, reflected by algae growth. The problem lies at the location of the previously mentioned situation (continuous crack and problem with rainwater drainage) shown in Figure 4.3.2 (l). The sometimes high air humidity leads to condensation on the glazing (r)

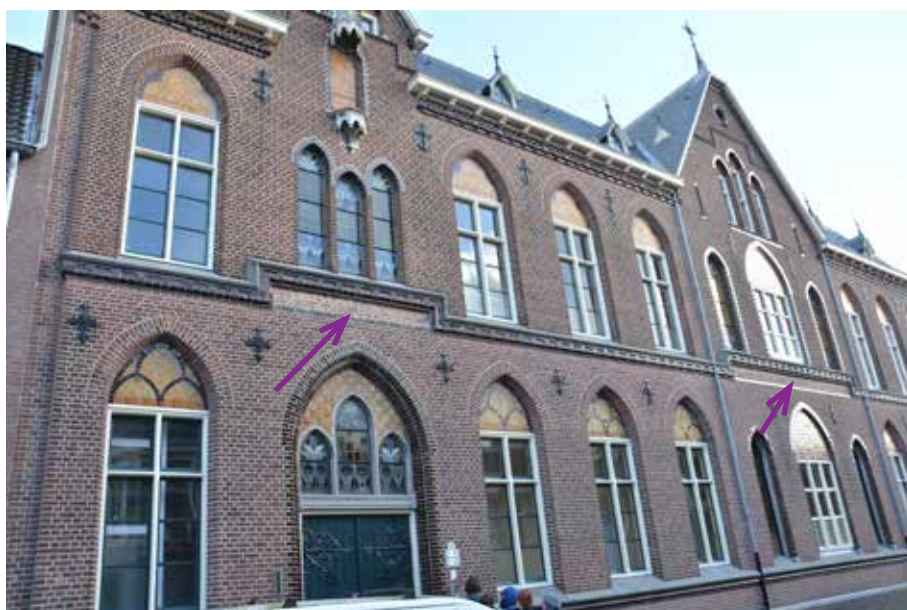
Figure 4.4.1 School in Tilburg. Maintenance and intervention carried out, based on the inspection and advice by MW; only the old name boards with inscriptions are missing (see arrows)

MW only deals with the technical state of conservation and technical defects, and does not reflect on building historical aspects, value and possibly connected subjects: an example is the restored school in Tilburg, where the original board indicating the destination of the building on the façade, being an important reminder of the historic value of the building (fig. 4.4.1), was removed.

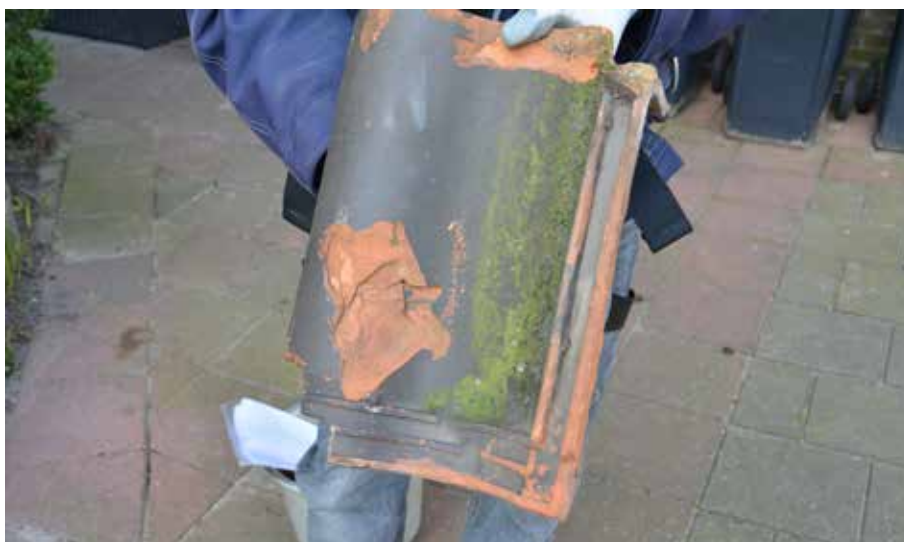
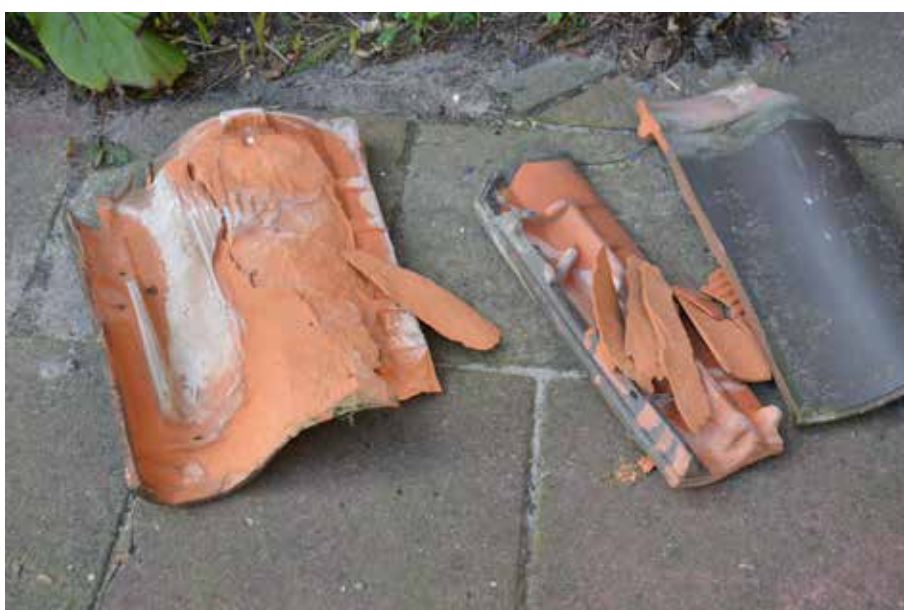
Figure 5.2a/b A more urgent problem: several tiles show frost damage, causing leakage, with consequential danger for the underlying timber construction

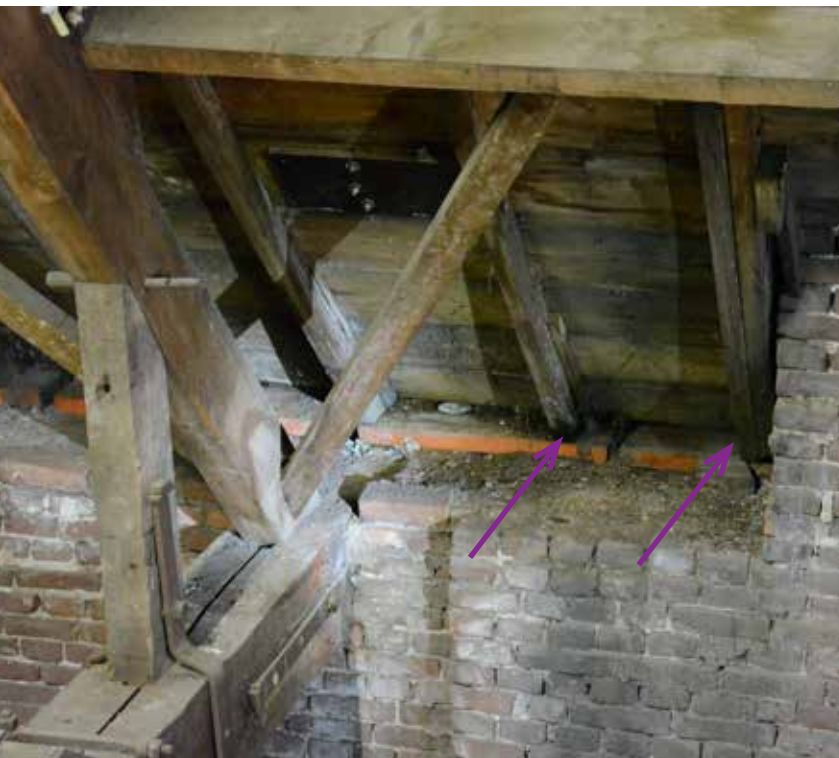
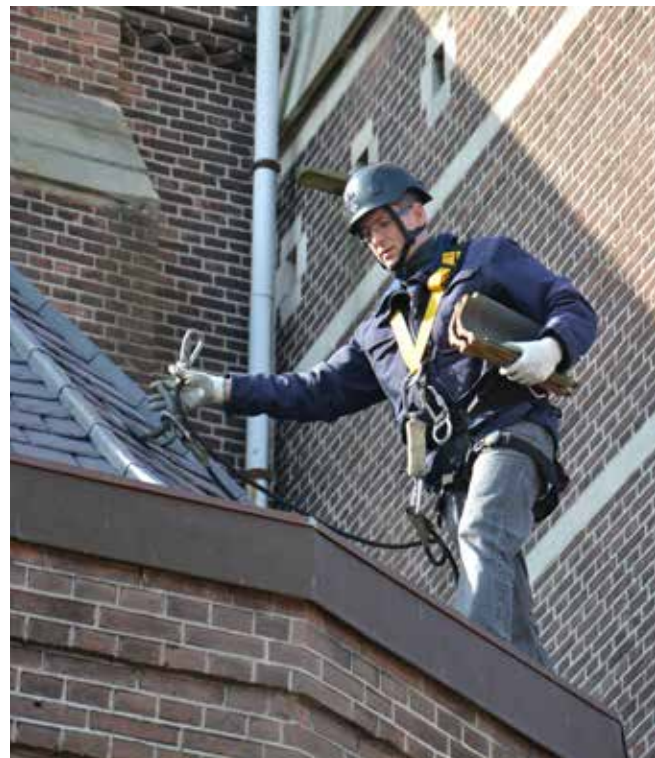
*Figure 5.3a/b The consequential damage: the timber construction (see arrows) has become wet. Fortunately, the problem was approached immediately: tiles were replaced
Figure 5.4 a/b/c Problem as encountered and improved situation at the connection be-*

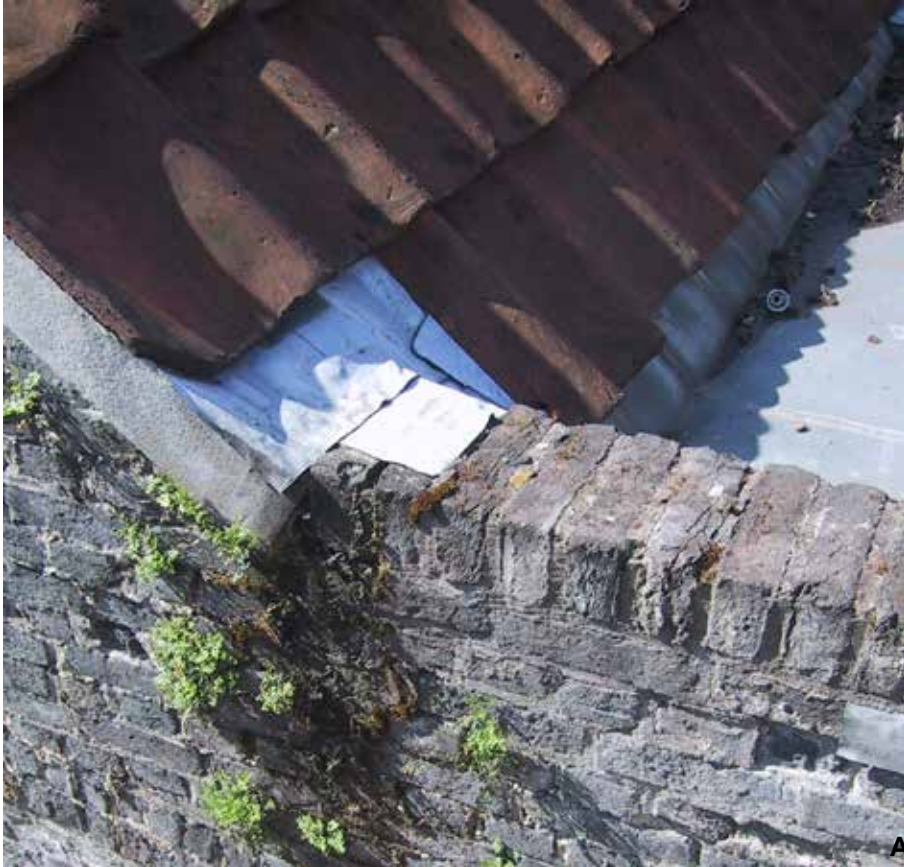
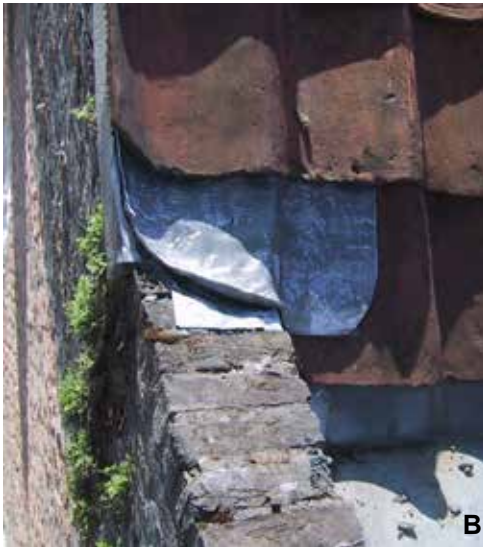
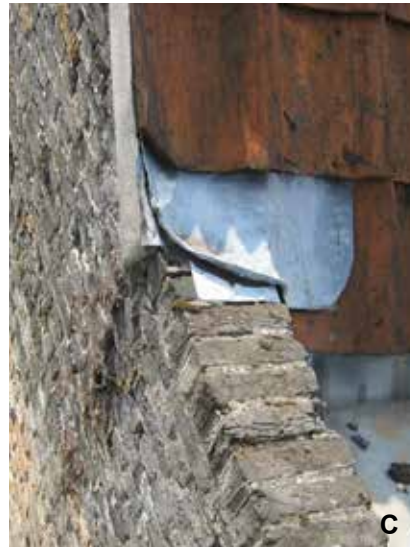
tween roof and façade (a. As encountered; b. Improved; c. Condition two years later)

That this sort of observation does not stand by itself and furthermore comprises a broad scale of problems is illustrated by fig. 5.4 a/b/c. MW found a moisture related problem at the joint between a roof and a façade. During the inspection, lead was bent just a little so that rainwater running from the roof was fed into the roof gutter and no longer ran across the façade. A follow-up inspection two years later (fig. 5.4c) showed that the solution worked and that even the plant growth on the façade had disappeared.

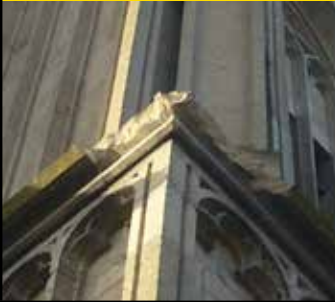
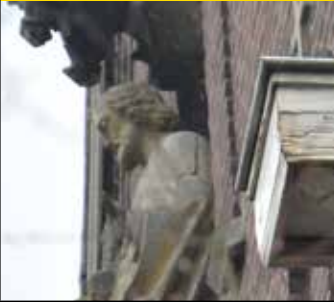
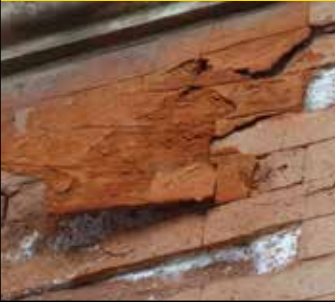
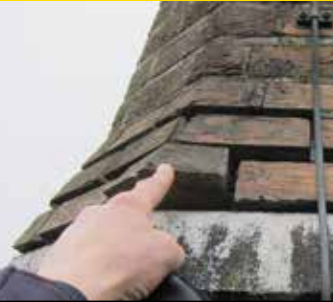
Cornices and similar	Natural stone sculptures and ornaments	layering and spalling of masonry	Loose elements at great height
Rusting iron

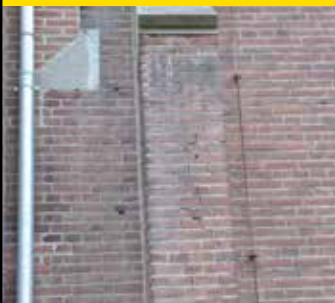
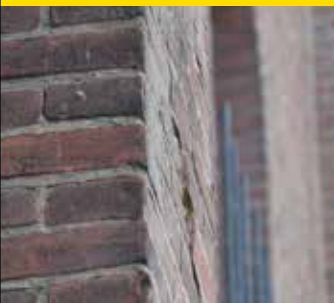
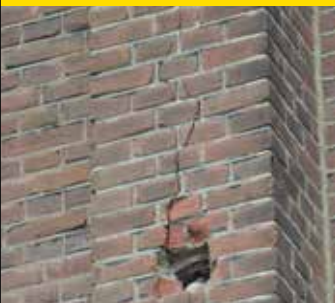
Cracks	Pushed out parts of masonry	Loss of adhesion/falling parts of masonry	In all cases danger of personal injury to passers-by
Forming of cracks (swelling compounds)

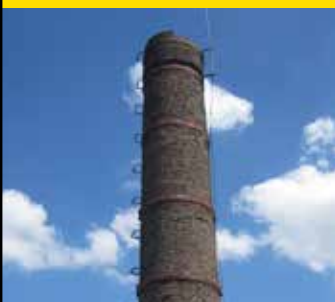
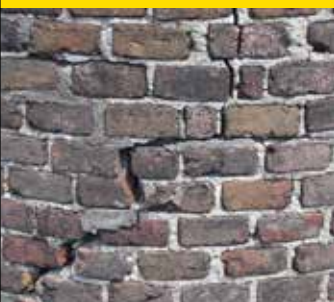
Old factory chimney	Forming of cracks possibly due to formation of swelling compounds in the mortar		Danger to surrounding buildings and passers-by

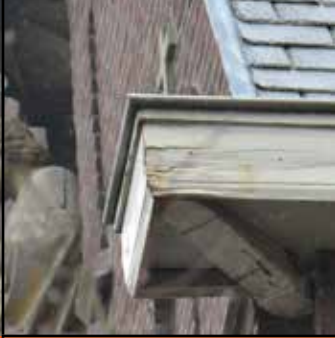
Leakage roof gutter followed by wood rot in wood panelling

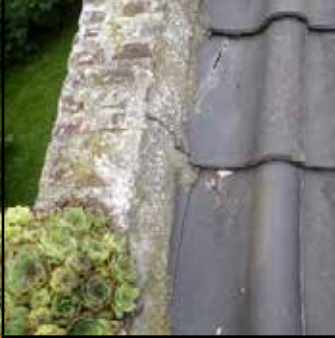
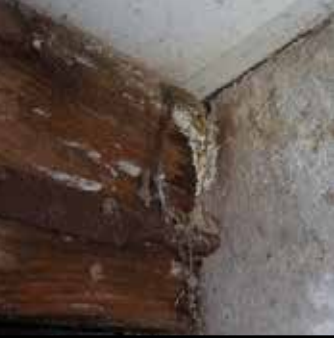
Cracked roof tiles	Underlying purlin showing considerable rot

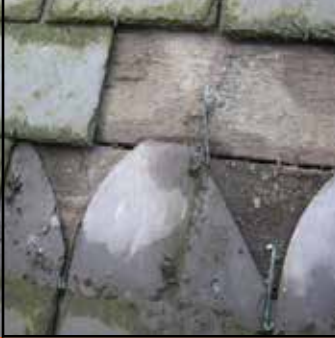
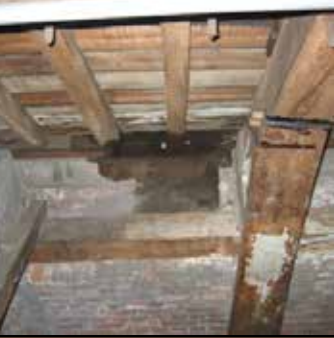
Overlap of slate tiles was too small (here slate tiles were removed)	Consequences of moist roof deck and wall plate in the inside

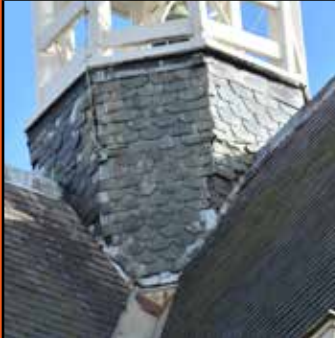
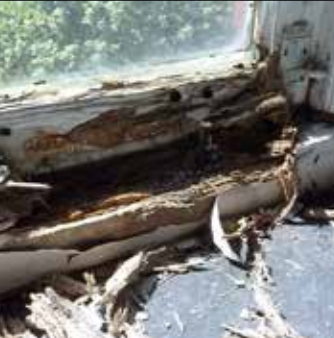
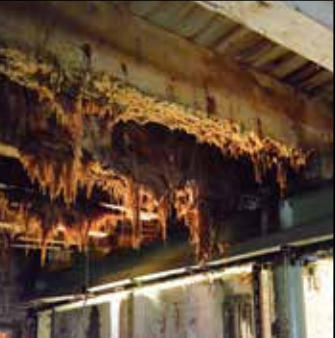
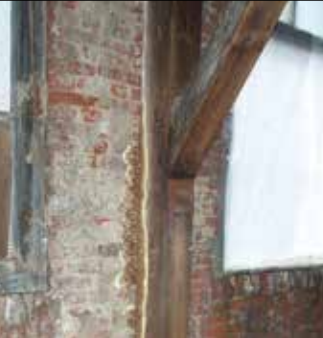
Overdue maintenance in terms of paintwork, roof covering, roof gutters and rain water drainage	Wood rot	Wood rot affecting structural parts	Wood rot, paired with dry rot infestation. Effect: (partial) removal even of non- infested wood, often (chemical) fungus control measures, removal and replacement of plaster-work. Moisture controlling measures are necessary

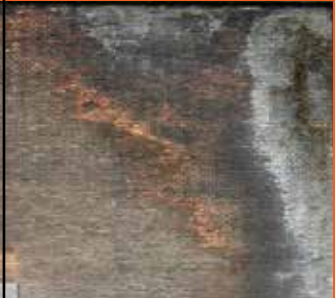
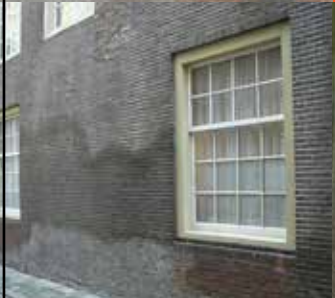
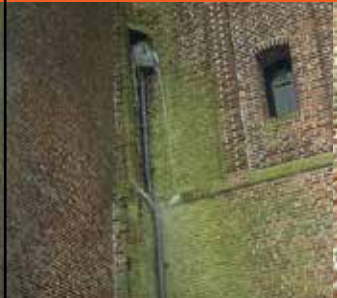
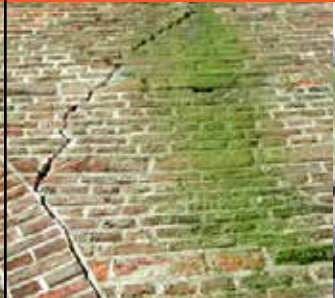
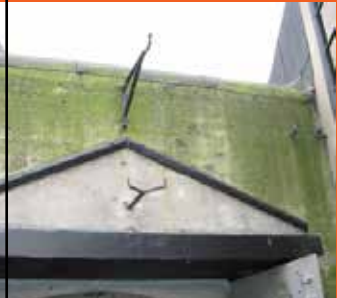
High moisture load on facade	Defect rainwater drainage: Algae growth visual damage	Visual damage	Necessity to remove source of moisture, cleaning, treatment with algicide

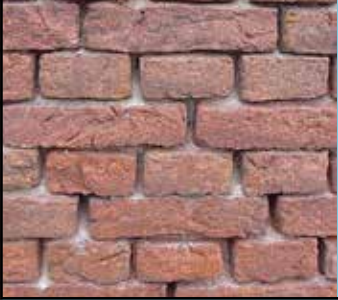
Sanding pointing

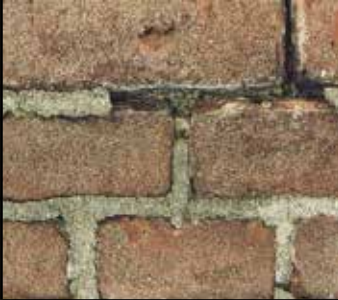
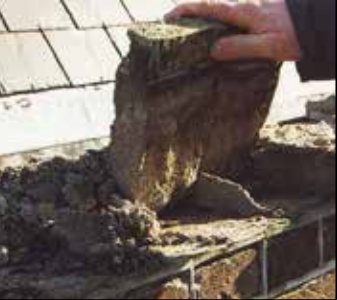
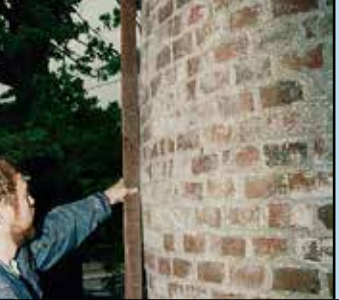
Push out of pointing combined with problems to bedding mortar	Frost damage to bedding mortar	Frost damage to bedding mortar	In depth replacement of bedding mortar to total replacement of damaged parts of masonry

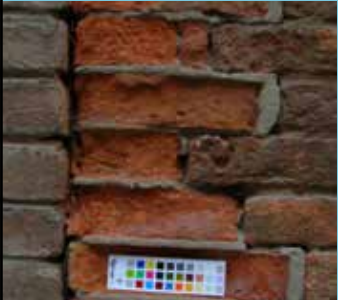
Incompatibility causing problems to brick

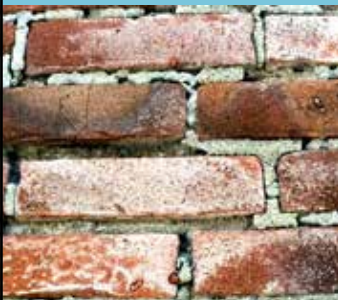
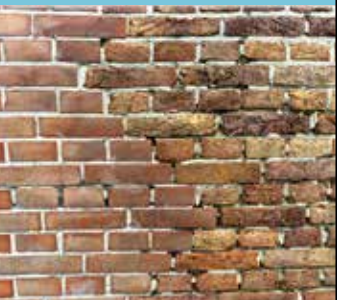
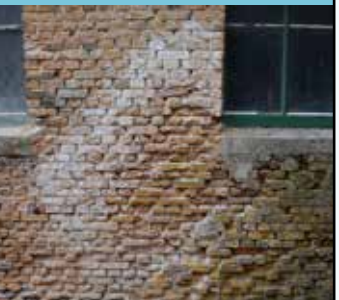
Effect of salt damage on masonry			Necessity to re-point, desalination

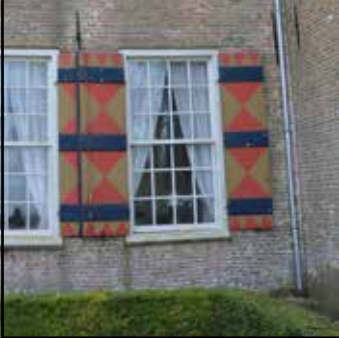
Differential settlement of two parts of a building, visible by a kink in the edge joints under the right-most window			In cases like this the problem has been present for some time or has grown slowly: immediate intervention is not necessary; however, monitoring the progress is recommended

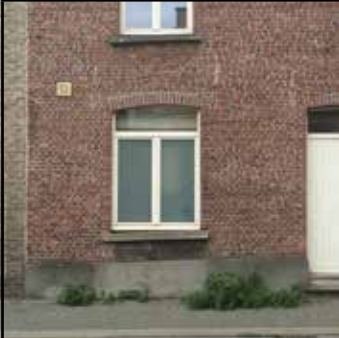
Differential settlement, mainly visible by the slanted position of the natural stone window sill(s)			In cases like this the problem has been present for some time or has grown slowly: immediate intervention is not necessary; however, monitoring the progress is recommended
