Changes in Cultural Heritage Activities: New Goals and Benefits for Economy and Society

CHANGES is a European Project supported by the JPI Heritage Plus program.

WP5**IMPLEMENTATION OF MAINTENANCE SYSTEMS:
INVESTIGATION ON EFFICACY OF MAINTENANCE PRACTICES IN ITALY****Responsible**

CASE STUDY N. 7: MONITORING - SAFETY FOR STRUCTURAL HAZARD.

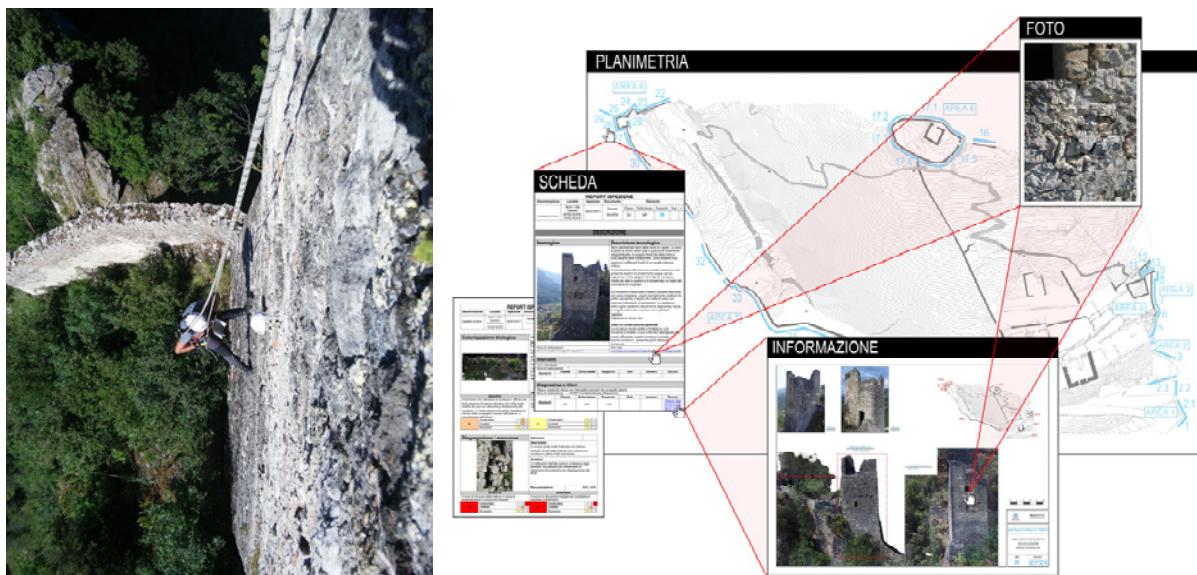
Arco Castle: inspection through ropes; report arranged in an IT support.

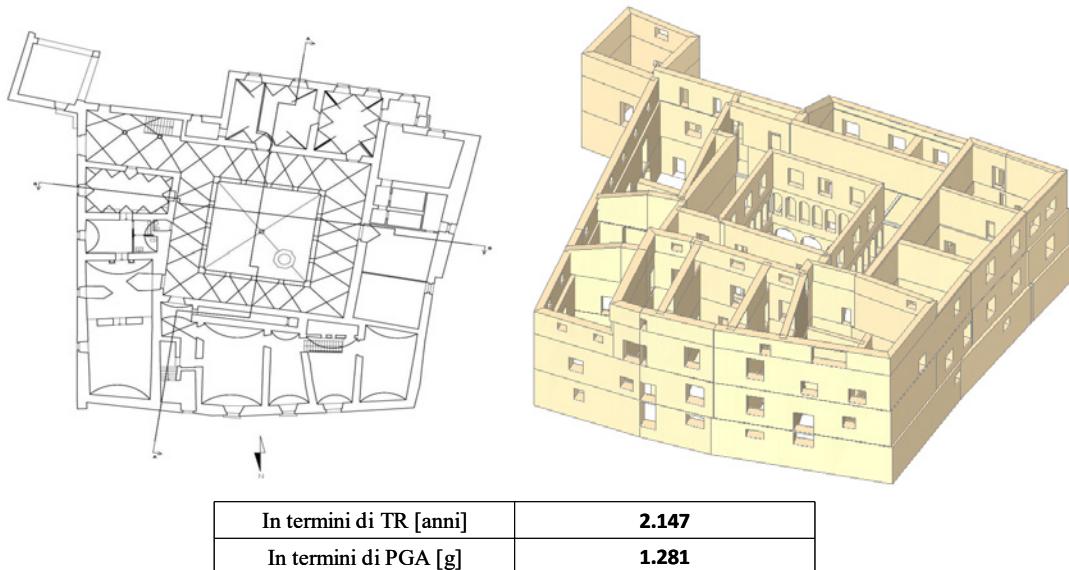
Evaluation of the seismic vulnerability at the Level LV1 in the Besta Palace in Teglio.

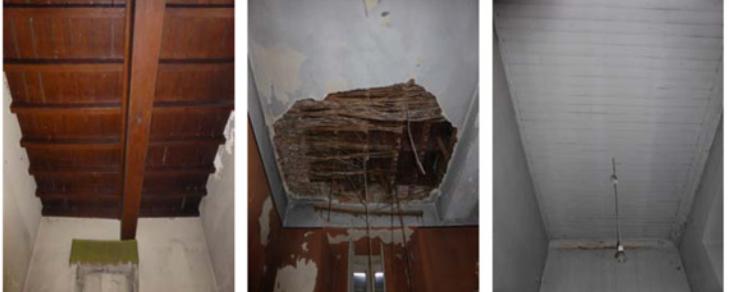
MOD.3.1 SCHEDA ANALITICA
DATA SOPRALLUOGO: dicembre 2015

<table><tr> <th>Degrado</th> <th>Gravità</th> <th>Urgenza</th> <th>Diffusione</th> <th>Note</th> </tr><tr> <td>(Cs) macchie di umidità</td> <td>3</td> <td>3</td> <td>20%</td> <td rowspan="6">1) Si segnala il crollo del controsoffitto in una delle camere del primo piano dell'ala nord. 2) L'appartamento è in stato di abbandono e tutti i controsoffitti in camera a canne presentano macchie di umidità (infiltrazioni provenienti dalla copertura), fessurazioni e rigonfiamenti.</td> </tr></table>

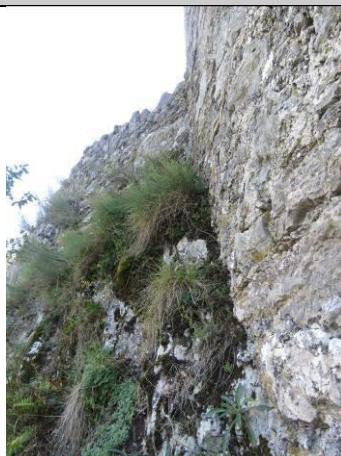
COLONIZZAZIONE BIOLOGICA				DIFFUSIONE	25-50%

DESCRIZIONE				
Il prospetto si presenta ricoperto di patine biologiche, che ricoprono in particolare le malte, mentre alcune piante erbacee sono presenti al piede				ISTRUZIONI				
La presenza della risega al piede della muratura favorisce l'accrescimento di piante superiori.				DOCUMENTAZIONE	IMG_0194			
GRAVITÀ				URGENZA				
Il fenomeno che interessa la muratura seppur diffuso non appare grave per tipologia e dimensioni delle specie.				La tipologia di vegetazione presente non comporta urgenze significative .				
1	CONSERVATIVA	1	2	3	CONSERVATIVA	1	2	3
	FRUIBILITÀ	1	2	3	FRUIBILITÀ	1	2	3
	ECONOMICA	1	2	3	ECONOMICA	1	2	3

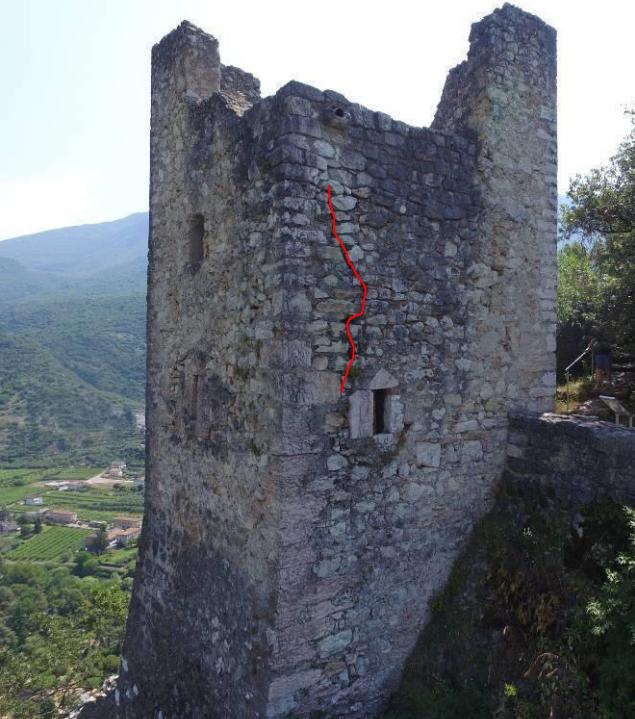
<p>Muro perimetrale Ovest della torre di Laghel. E' presente a metà altezza un'apertura trilitica. Il coronamento del muro non presenta sistemi di smaltimento acque; nello spigolo Sud-Ovest la muratura risulta più alta , evidentemente residuo del coronamento originale della torre. Da tale rialzo si è già staccato un blocco caduto all'interno della copertura. La parte alta della muratura appare ricostruita in sottosquadra, probabilmente per consentire l'appoggio della copertura. E' costituita da pietra grigia (come nella parte sottostante) ma senza scaglie di mattoni nei giunti. Lo spigolo Sud, costituito da pietra calcarea biancorosacea come la spigolo opposto, mostra un giunto di costruzione; il corpo murario è costituito da pietra grigia. Lo spigolo Nord è segnato da una fessura, attualmente sigillata.</p> <p>La muratura è realizzata in pietra calcarea sbozzata con posa irregolare, angoli costituiti da pietre squadrate e legata da malta di calce con inerti da millimetrici a centimetrici. La sigillatura delle fughe (sebbene attualmente degradata) risulta in origine molto alta a creare una superficie regolare. Esposizione Nord, Sud</p>

DESCRIZIONE							
				Alcuni disaggregazioni sono presenti in corrispondenza della fessura sigillata dello spigolo Nord e ne attestano la non accurata sigillatura							
				ISTRUZIONI							
				Tali disaggregazioni non paiono attribuibili a movimenti attivi, ma possono costituire un problema in quanto possono costituire una via preferenziale per l'infiltrazione di acque meteoriche all'interno del corpo murario							
				DOCUMENTAZIONE		IMG_4547					
GRAVITÀ				URGENZA							
Il fenomeno che interessa la muratura seppur diffuso non appare grave per tipologia e dimensioni delle specie.				I fenomeni sono in progressione, ma non vi sono parti a rischio distacco							
2	CONSERVATIVA	1	2	3	2	CONSERVATIVA	1	2	3		
	FRUIBILITÀ	1	2	3		FRUIBILITÀ	1	2	3		
	ECONOMICA	1	2	3		ECONOMICA	1	2	3

AZIONI		RISTILATURA PROFONDA DEI GIUNTI										
1	FESSURAZIONE DISGREGAZIONE	Prospetto esterno										
		ATTIVITA'	CLASSI	SOTTOC.	SUPPORTO	SUB	NUM	MODALITÀ	ACCESSIBILITÀ	DATA	OPERATORE	
		A	Sv	Mp	27			Lavoro	In fune	Medio termine	Operaio OG2	
2	DISGREGAZIONE CORONAMENTO	REVISIONE CORONAMENTO										
		Coronamento	ATTIVITA'	CLASSI	SOTTOC.	SUPPORTO	SUB	NUM	MODALITÀ	ACCESSIBILITÀ	DATA	OPERATORE
		A	Sv	Mp	27			Lavoro	In fune	breve termine	Operaio OG2

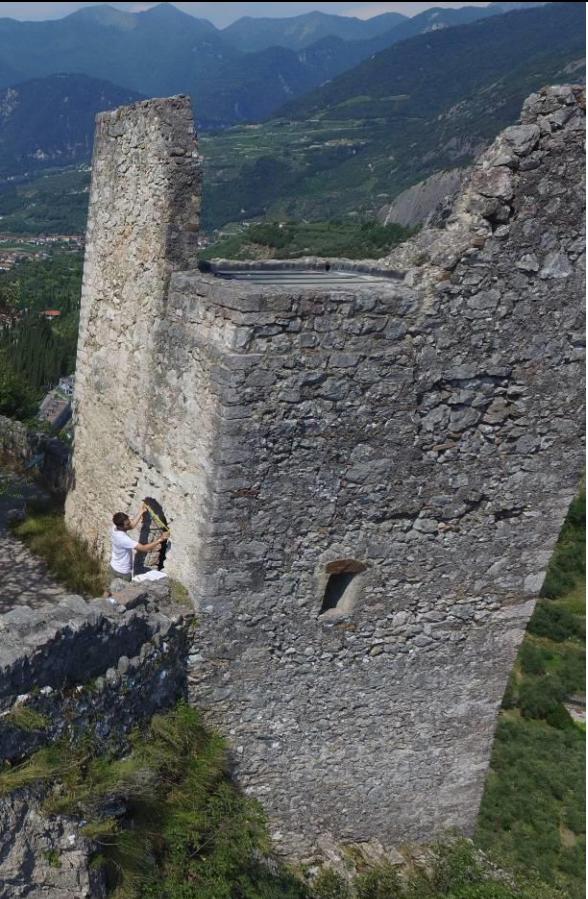
<p>Muro perimetrale Sud della torre di Laghel, dove ha sede l'attuale accesso principale. E' la più bassa delle quattro pareti della torre in quanto spicca a partire dal livello calpestabile esterno.</p> <p>Il coronamento del muro non risulta; sulla sommità dello spigolo Sud-Ovest la muratura risulta più alta, in continuità con la parete Ovest, evidentemente residuo del coronamento originale della torre. La parte alta della muratura, probabilmente ricostruita per consentire l'appoggio della copertura, è realizzata in sottosquadra.</p> <p>La muratura è realizzata in pietra calcarea sbozzata con posa irregolare, angoli costituiti da pietre squadrate e legata da malta di calce con inerti da millimetrici a centimetrici. La sigillatura delle fughe (sebbene attualmente degradata) risulta in origine molto alta a creare una superficie regolare.</p>
Anno di realizzazione	STATO DI CONSERVAZIONE GENERALE: Non noto

La muratura sulla sommità della parete presenta fessurazioni verticali parallele. Tali fessurazioni evidenziano la disgregazione strutturale di tale muratura alla quale deve essere correlata alla caduta di un blocco sul lato interno (vedi scheda 27).							
			ISTRUZIONI		Le fessurazioni devono essere sigillate.					
			DOCUMENTAZIONE		IMG_4545					
GRAVITÀ			URGENZA							
Il fenomeno che interessa la muratura sebbene localizzato risulta puntualmente grave in quanto questa muratura prospetta sul sottostante percorso aperto al pubblico.			Le pietre risultano non legate con possibilità di caduta delle medesime nell'immediato.							
3	CONSERVATIVA	1	2	3	3	CONSERVATIVA	1	2	3	
	FRUIBILITÀ	1	2	3		FRUIBILITÀ	1	2	3	
	ECONOMICA	1	2	3		ECONOMICA	1	2	3

AZIONI		RISTILATURA PROFONDA DEI GIUNTI									
1	FESSURAZIONE	Prospecto esterno									
		ATTIVITÀ	CLASSI	SOTTOC.	SUPPORTO	SUB	NUM	MODALITÀ	ACCESSIBILITÀ	DATA	OPERATORE
2	DISGREGAZIONE CORONAMENTO	REVISIONE CORONAMENTO									
		Coronamento	ATTIVITÀ	CLASSI	SOTTOC.	SUPPORTO	SUB	NUM	MODALITÀ	ACCESSIBILITÀ	DATA
		A	Sv	Mp	28			Lavoro	In fune	breve termine	Operaio OG2

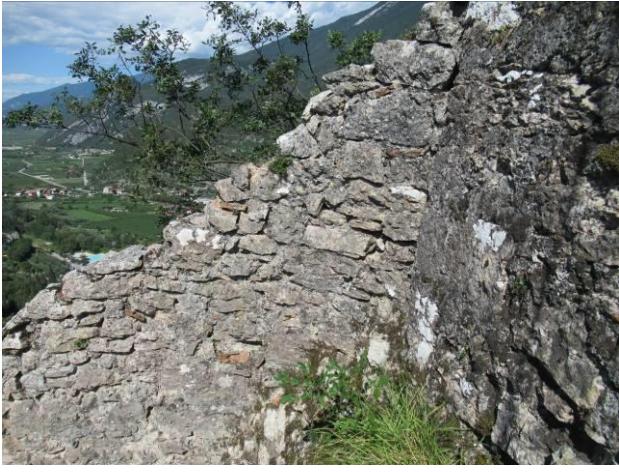
DISGREGAZIONE CORONAMENTO				DIFFUSIONE					
				DESCRIZIONE

Il coronamento della muratura appare sensibilmente disgregato, con mancanza di malta nei giunti; i blocchi risultano quindi malamente ammorsati.					
ISTRUZIONI				Il coronamento deve essere revisionato mediante creazione di una superficie di sacrificio che consenta di allontanare le acque meteoriche con sigillatura idonea dei giunti.					
				DOCUMENTAZIONE	IMG_4510				
GRAVITÀ				URGENZA					
Vista la posizione strapiombante della muratura la caduta dei blocchi può coinvolgere il territorio sottostante.				Il coronamento alla sommità della muratura non ha protezione per cui i fenomeni di degrado progrediscono.					
2	CONSERVATIVA	1	2	3	2	CONSERVATIVA	1	2	3
	FRUIBILITÀ	1	2	3		FRUIBILITÀ	1	2	3
	ECONOMICA	1	2	3		ECONOMICA	1	2	3

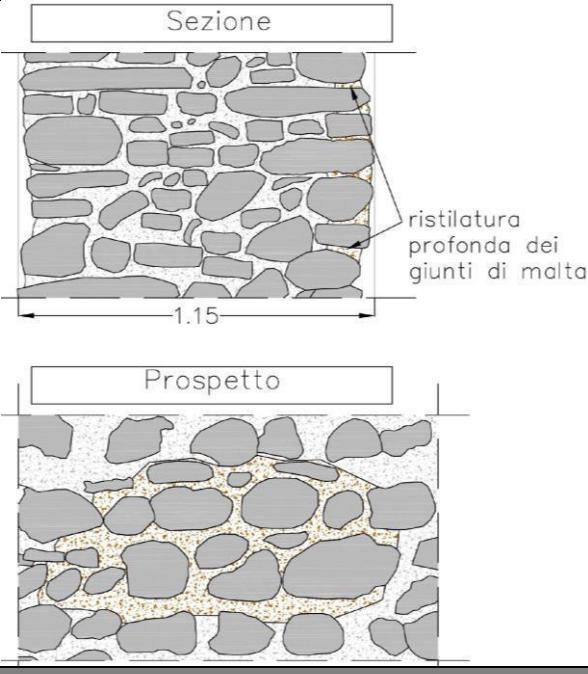
INTERVENTO: RISTILATURA PROFONDA DEI GIUNTI

DANNO: DISGREGAZIONE DEI GIUNTI DI MALTA

<p>Fenomeni di disaggregazione della malta nei giunti. Tali fenomeni non paiono attribuibili a movimenti attivi, ma possono rappresentare un problema in quanto costituiscono una via preferenziale per l'infiltrazione di acque meteoriche all'interno del corpo murario.</p>

<ol style="list-style-type: none"> Scarifica per 10/15 cm del giunto, evitando di rimuovere tutta la malta, con utilizzo di attrezzatura a sola rotazione in modo da non causare vibrazioni alla struttura; Rifinitura della rimozione a mano con scalpello e/o cazzuola e pulizia accurata con aria compressa per rimuovere il velo di malta residuo; Verifica della correttezza della profondità di scarifica con misure a campione; Lavaggio con acqua per evitare i residui pulverulenti della malta e per idratare la malta esistente; Ristilatura in profondità della malta all'interno dei giunti mediante malta applicata a cazzuola oppure mediante apparecchiatura di estrusione idonea per la granulometria della malta stessa - adagiare bene sul fondo del giunto le prime quantità di malta per farle aderire agli strati più profondi preesistenti ed alla pietra; Attendere almeno mezz'ora per consentire il raggiungimento di una sufficiente plasticità ed evitare il rifluimento della malta e quindi procedere ad un'ulteriore ristilatura più superficiale.

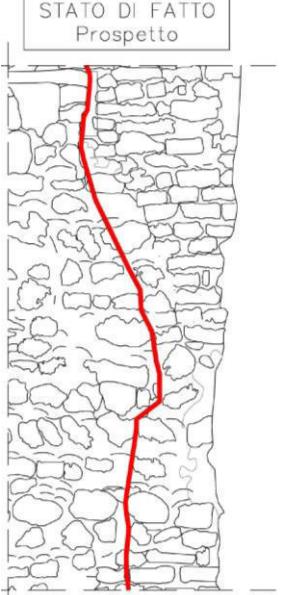
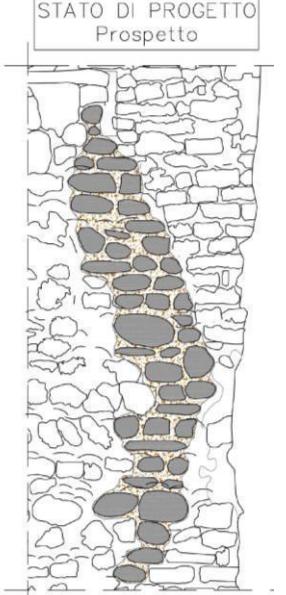
INTERVENTO: CONSOLIDAMENTO MEDIANTE TECNICA DEL CUCI-SCUOLO

DANNO: FESSURAZIONI

Fessurazioni verticali parallele che evidenziano la disaggregazione strutturale della muratura.

</div> </div>	<ol style="list-style-type: none"> Delimitazione della parte di muratura da sostituire ed individuazione dei cantieri successivi che dovranno essere alternati in modo da poter sempre disporre di una sezione sufficiente di muratura resistente; Eventuale puntellazione della porzione di muratura sovrastante la zona di intervento; Rimozione, eseguita con attrezzi manuali, del cantiere di muratura individuato fino al contorno reputato sano; Lavaggio con acqua per evitare i residui pulverulenti della malta e per idratare la malta esistente; Ricostruzione di nuova apparecchiatura muraria, ad esclusione dell'ultimo filare, utilizzando malta a base di calce, curando particolarmente l'ammorsamento laterale con la muratura esistente; Forzatura della nuova muratura con la sovrastante esistente mediante l'inserimento di cunei di legno da controllare e sostituire, a ritiro avvenuto, con pietrame e malta a ritiro compensato fino al corretto riempimento degli spazi.

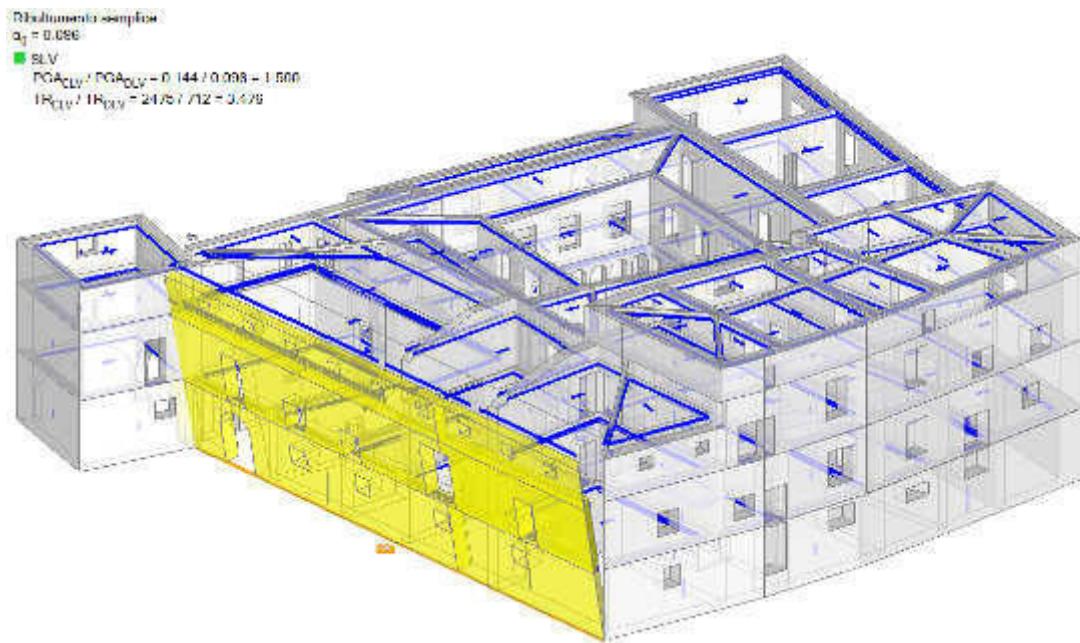
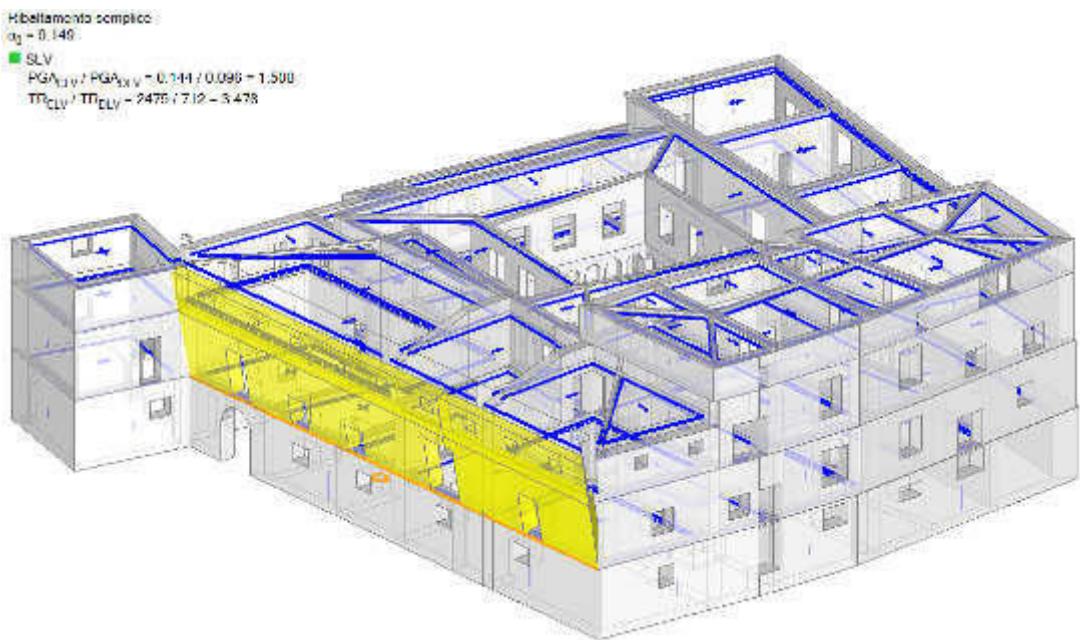
A)RIBALTIMENTO FACCIA EST GLOBALE – CERNIERA 1 AL PT-

MECCANISMO DI RIBALTIMENTO	IRS_{PGA}	IRS_{TR}
a) facciata Est globale rispetto:		
cerniera 1 (P.T.)	> 1.500	> 3.476
cerniera 2 (P.1)	> 1.500	> 3.476
cerniera 3 (P.2)	> 1.500	> 3.476

e) facciata Sud-Est rispetto alla cerniera:		
cerniera 1 (P.T.)	0.885	0.726
cerniera 2 (P.1)	> 1.500	> 3.476
cerniera 3 (P.2)	> 1.500	> 3.476
f) facciata Est parziale:		
cerniera 1 (P.T.)	> 1.500	> 3.476
cerniera 2 (P.1)	> 1.500	> 3.476
cerniera 3 (P.2)	> 1.500	> 3.476

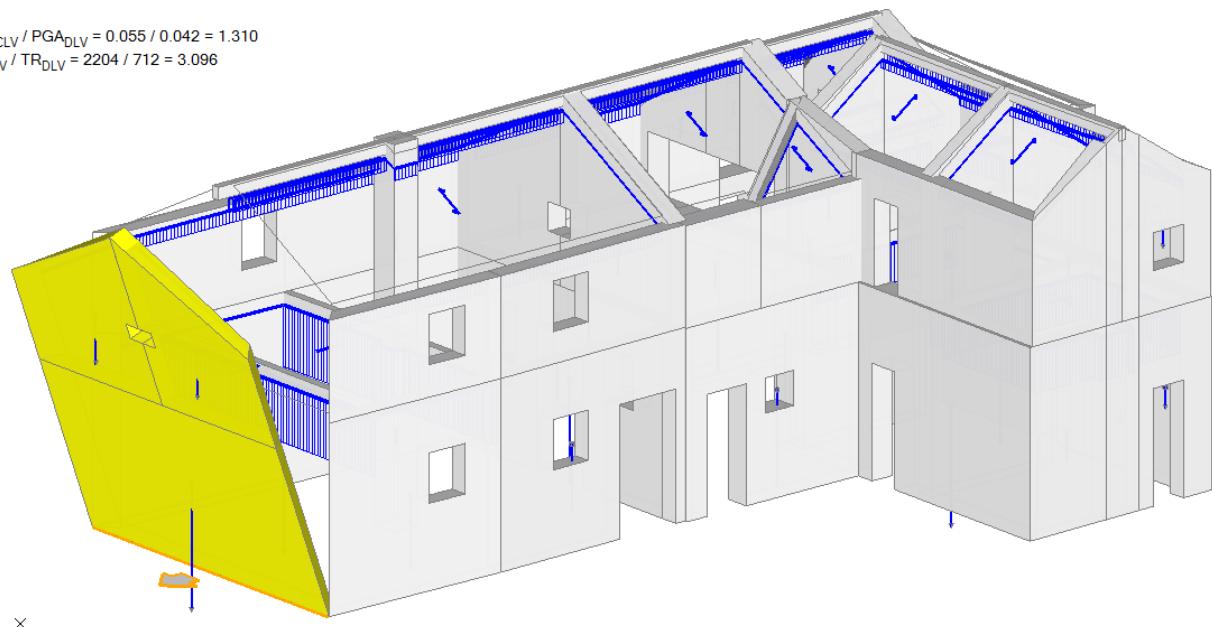
a) RIBALTIMENTO FACCIA OVEST GLOBALE – CERNIERA 1 AL PT-

$$\text{PGA}_{\text{CLV}} / \text{PGA}_{\text{DLV}} = 0.055 / 0.042 = 1.310$$

$$\text{TR}_{\text{CLV}} / \text{TR}_{\text{DLV}} = 2204 / 712 = 3.096$$

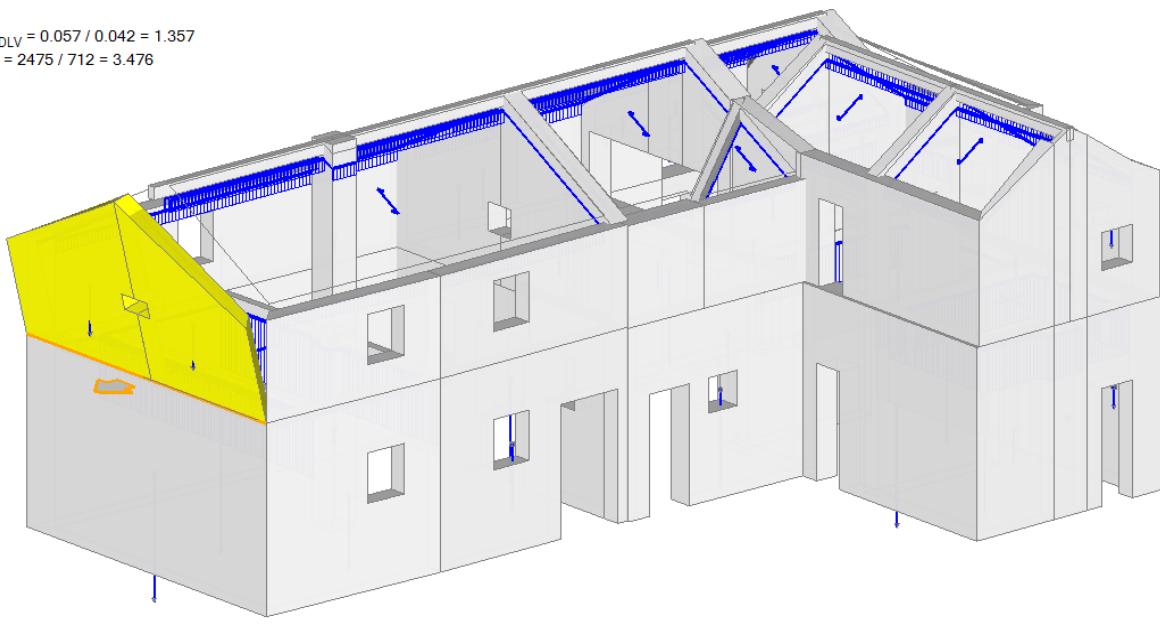
a) RIBALTIMENTO FACCIA OVEST GLOBALE – CERNIERA 2 AL P1-

$$\text{PGA}_{\text{CLV}} / \text{PGA}_{\text{DLV}} = 0.057 / 0.042 = 1.357$$

$$\text{TR}_{\text{CLV}} / \text{TR}_{\text{DLV}} = 2475 / 712 = 3.476$$
